**Aerial Infrared
Roof Moisture Survey of
Collin County Justice Center
McKinney, TX
March 31, 2017**

Aerial Infrared Roof Moisture Survey Report

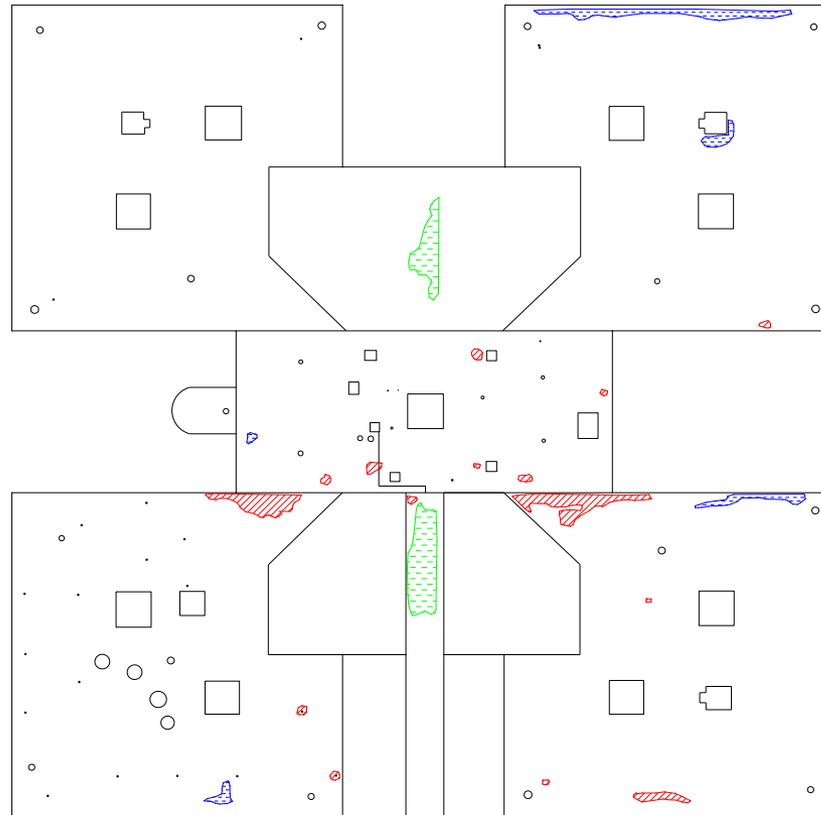
Building 02

02 Probable wet area (~0.72%)

02 Possible wet area (~0.53%)

02 Ponding area (~0.77%)

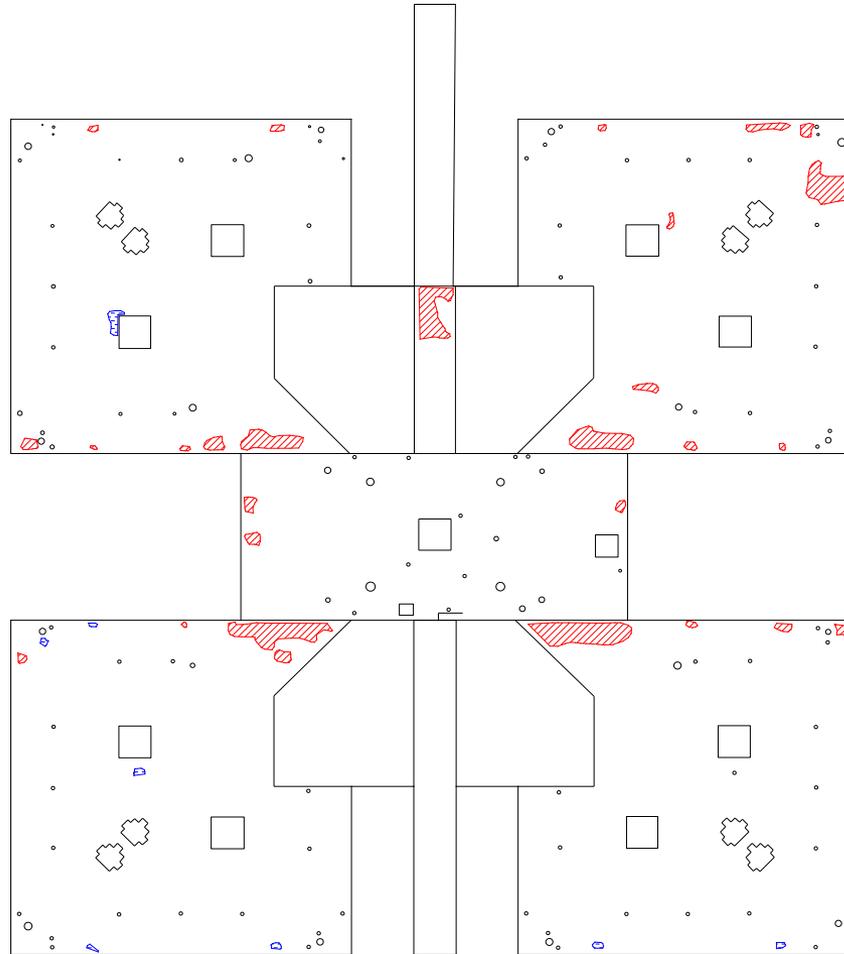
Building 03

03 Probable wet area (~1.74%)

03 Possible wet area (~0.09%)

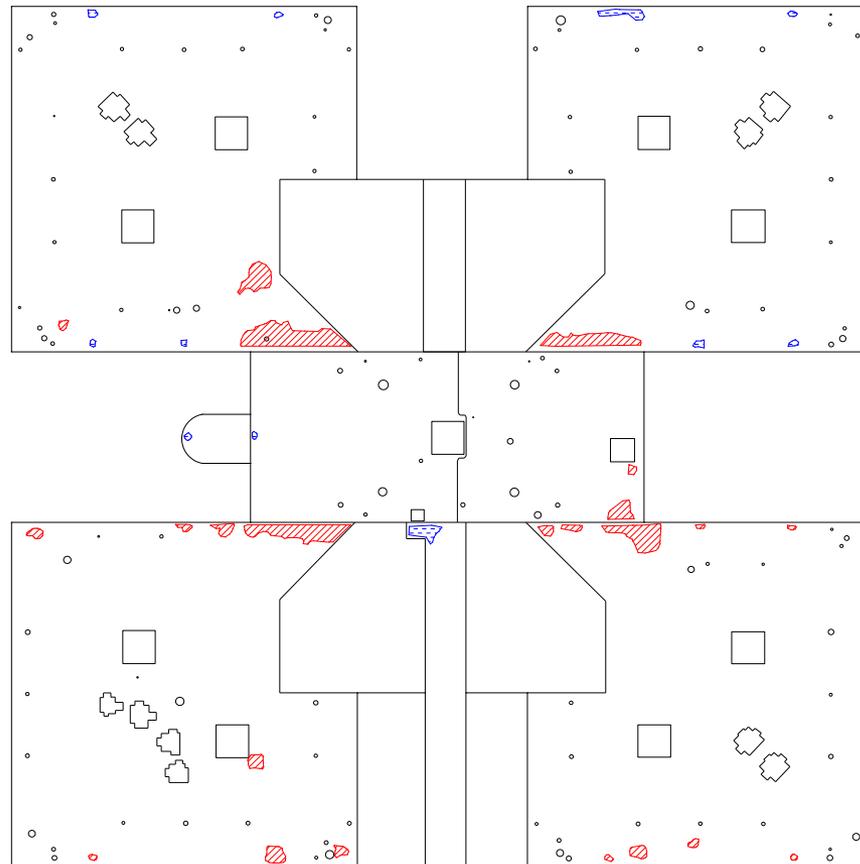
Building 04

04 Probable wet area (~1.27%)

04 Possible wet area (~0.15%)

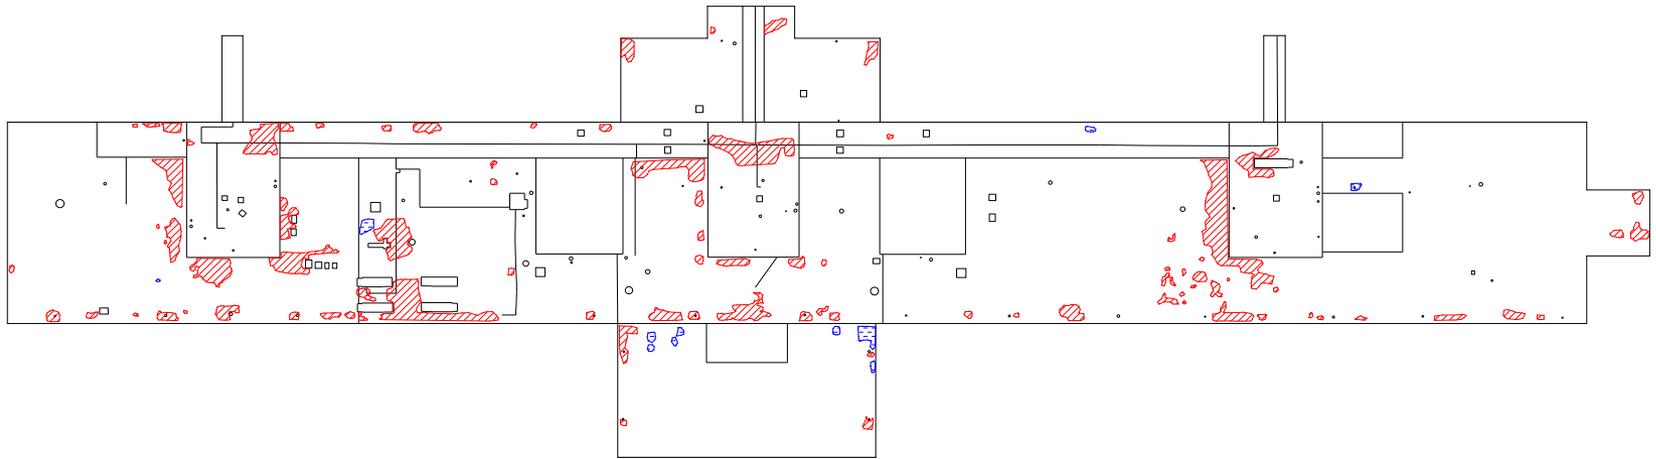
Building 05

05 Probable wet area (~4.88%)

05 Possible wet area (~0.21%)

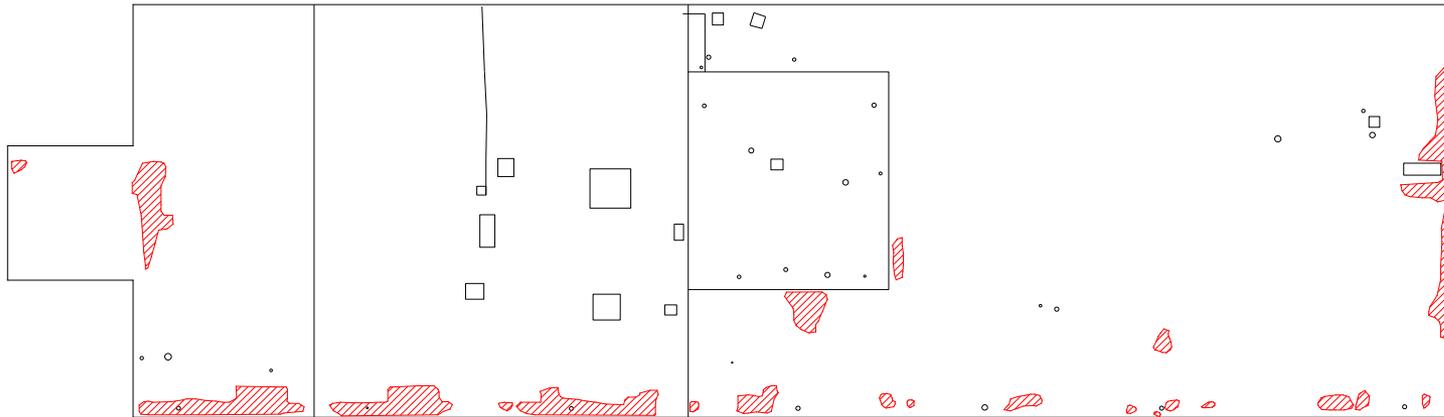
Building 06

06 Probable wet area (~3.08%)

06 Possible wet area (NONE)
