RE: Collin County Courthouse Addition  
Owner Project #R0508003.00  
Turner Project #1692600

Subject: PCO-66, Steel Revisions to the Penthouses

PCO No.: 066 R3  
 PCO Title: **Corrective Action at CMU Corners of Penthouse**  
 Project: Collin County Courthouse Addition  
 Project No.: R0508003.00

# ARCHITECT'S FIELD REPORT

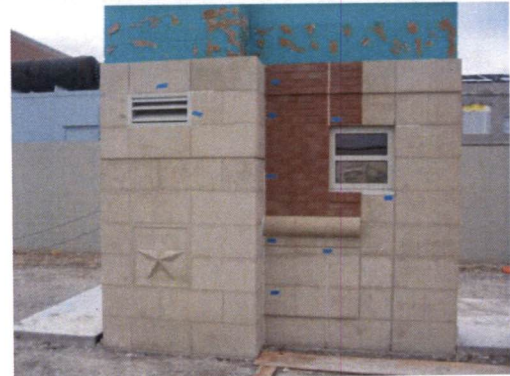
### 2. Exterior Mock Up

- Mock up is missing GFRC, metal parapet cap, all pre-finished flashings on cap
- Current mortar color in brick deviates too far from control sample
- Mock up will need stairs for final coordination and approvals
- Cast stone is inconsistent in color with stains and discoloration throughout the mock up.
- NOTE: Specifications section 01420/3.01/F states "Accepted mock up shall be a comparison standard for the quality of the Work."

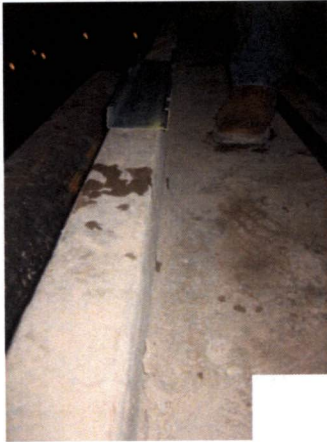
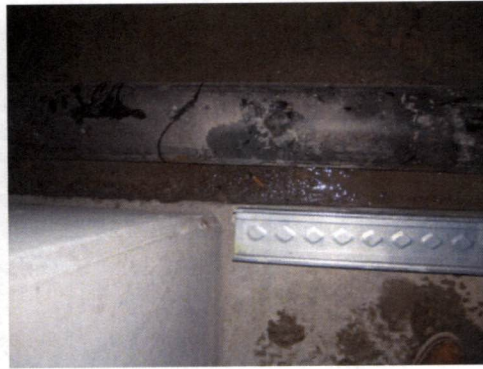
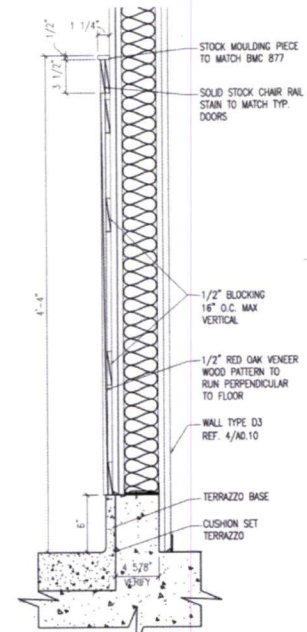
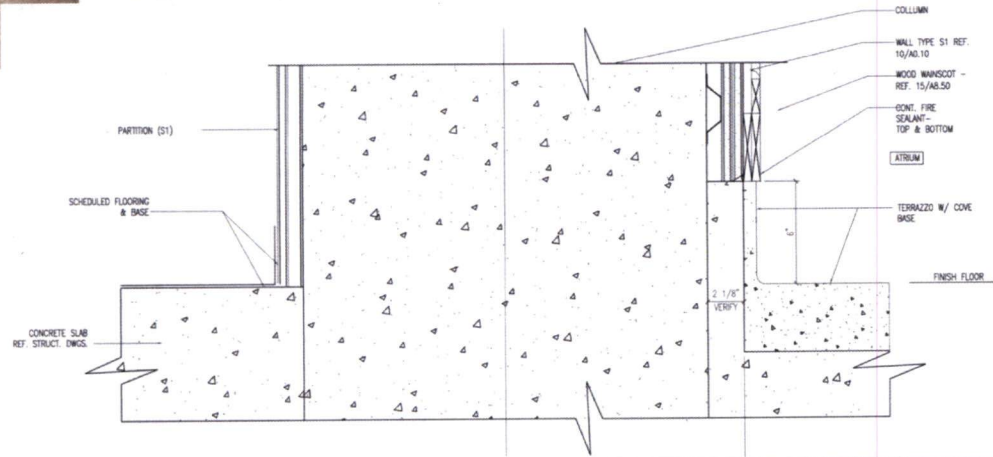
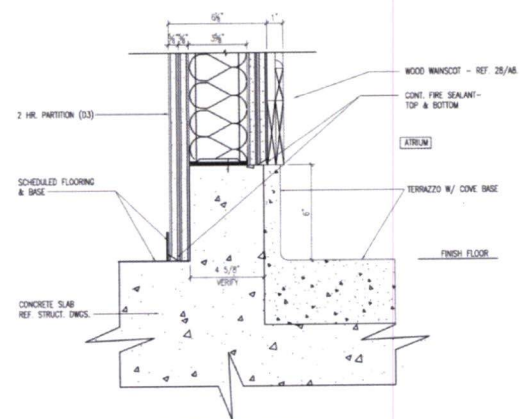
3. Interior curbs on Level 1 are shown to be 3" wide curb on 13/S4.02 and 4 5/8" on 17/A8.50. PGAL was not afforded the opportunity to clarify which dimension was to be followed. Currently, all curbs were installed at 3". The photo below shows what was thought to be an acceptable layout. However, after looking at the actual wall thickness to include 1/2" blocking at the veneer wall panels. The actual dimension from the face of gypsum finish on the corridor side is 1 1/4" plus 1/4" overhang of the panel over the terrazzo covered base. The curb must be provided per the Architectural drawings. The current curb face at the corridor may not be installed per detail 13/A8.50.

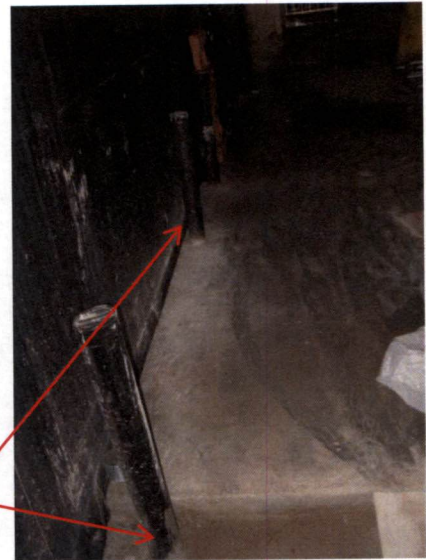
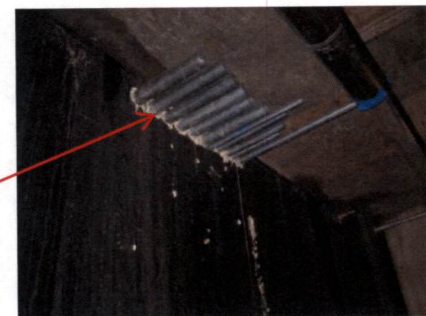
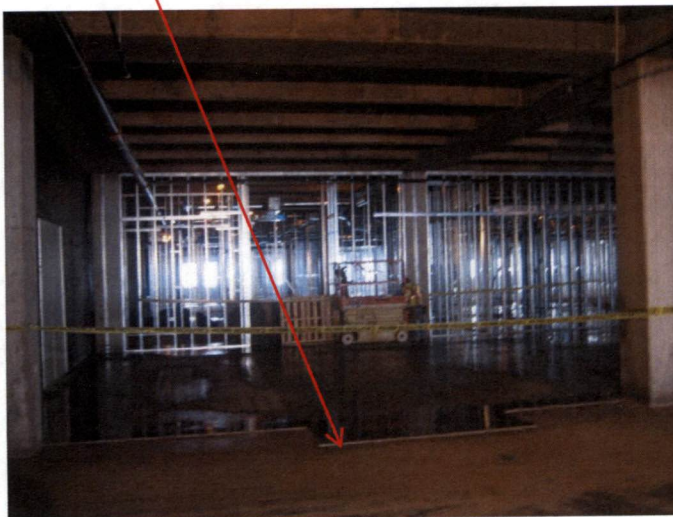
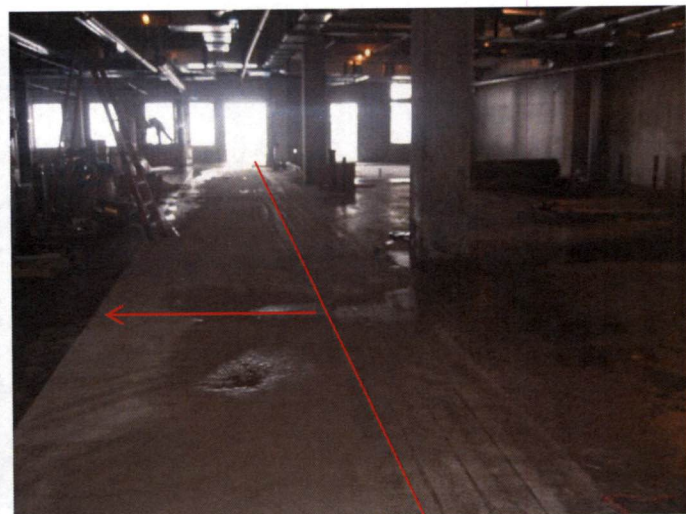
6. Photos below show the 3/8" slab depression is still underway. The depression at column line E seems complete.
7. The area north of column line 2 is either incomplete or is being proposed to be feathered out. NOTE: It will not be acceptable to feather this tiled area out. The depression should be provided as shown on the Structural and Architectural drawings.

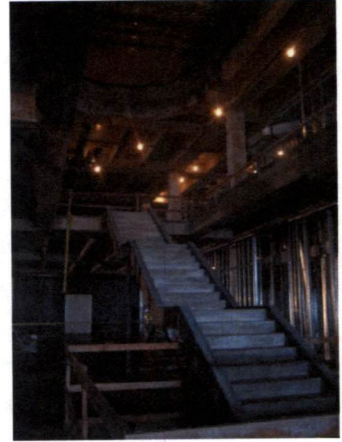
8. NOTE: Specifications section 05530/1.05/B and 05530/3.01/A require the ornamental stainless steel handrail system to be installed by an authorized representative of the manufacturer.

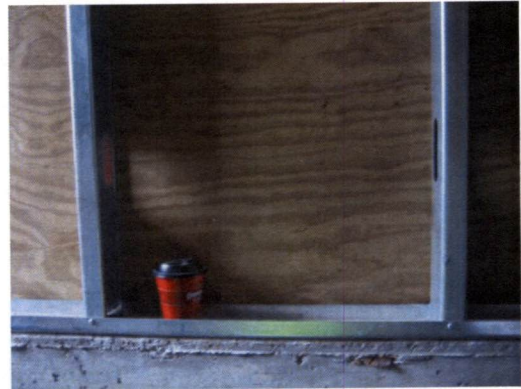
9. All food and refuse must be removed from the project interior. All food materials will potentially become sources of mold.

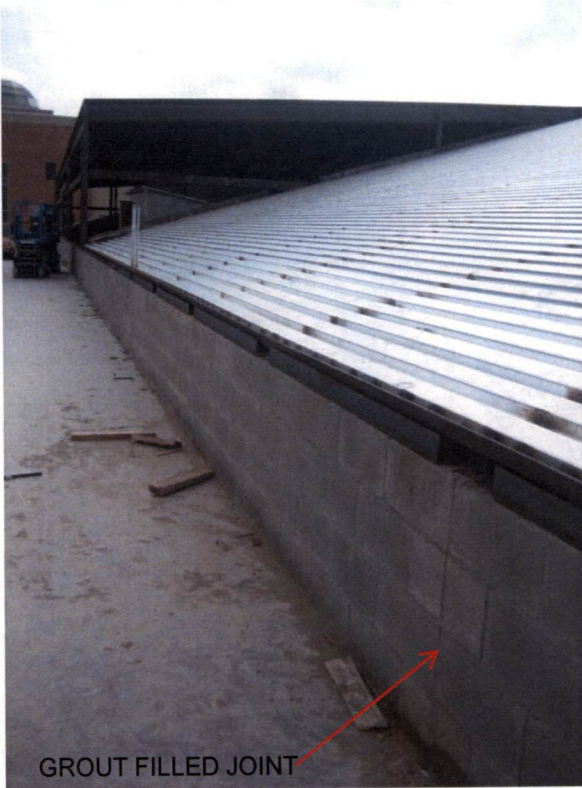
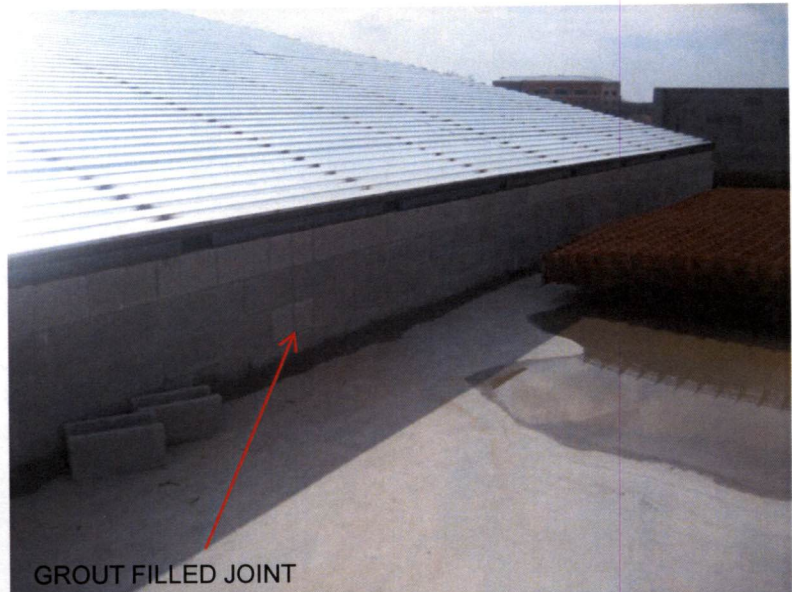
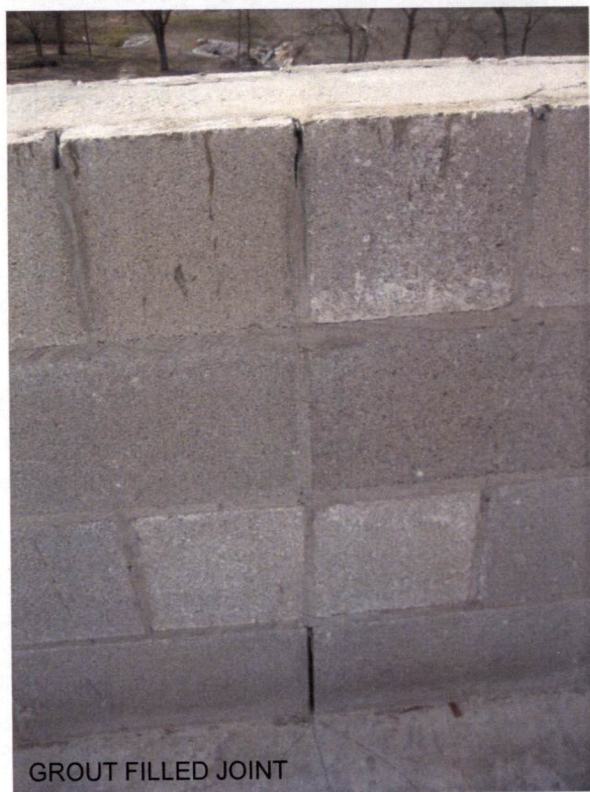
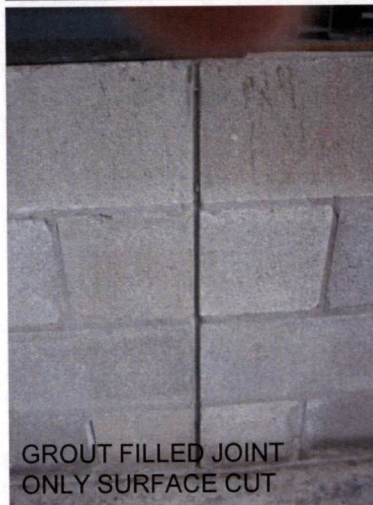
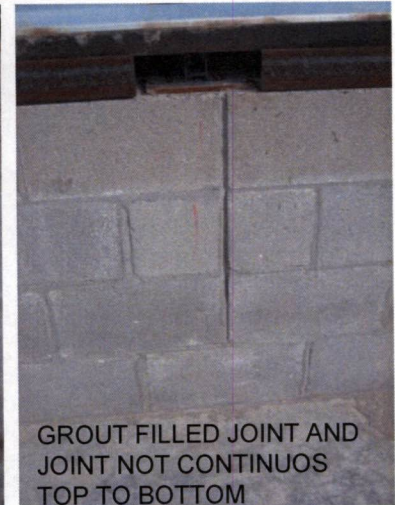
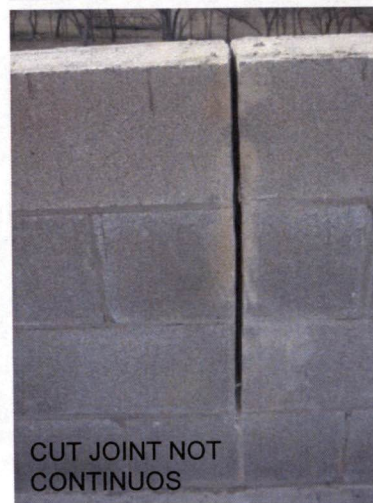
11. Control joints in parapet wall are not per Contract Documents. Control joints are not to be grout filled and should be continuous through the block from top to bottom of wall at minimum 30'-0" increments

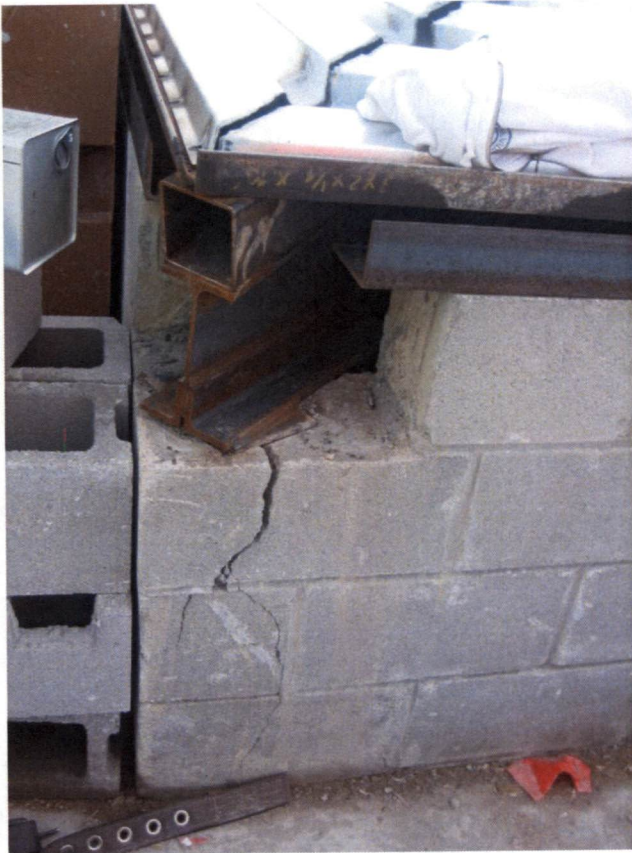
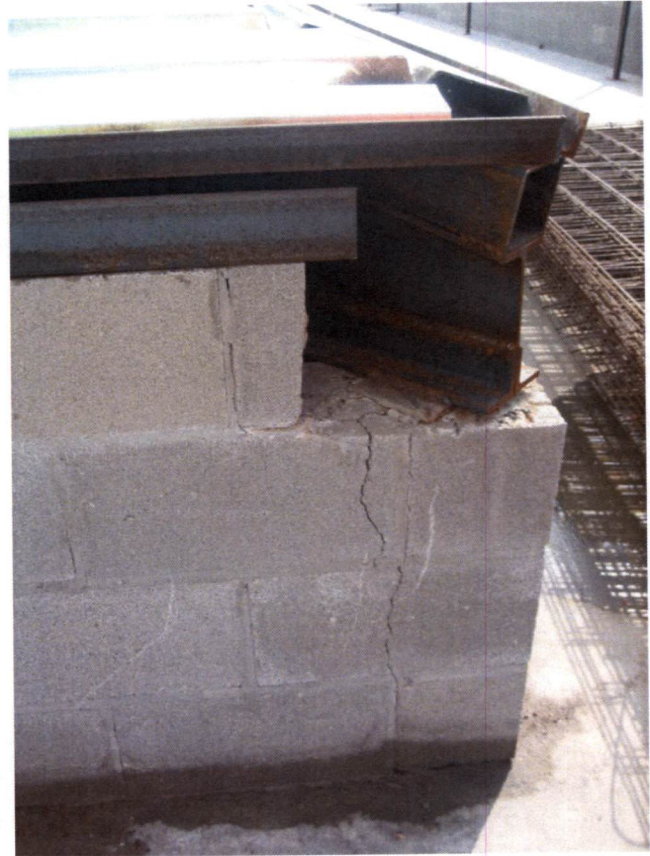
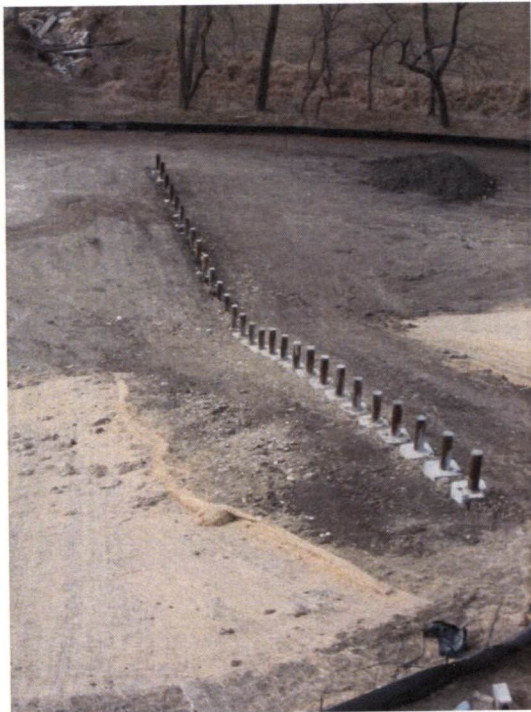
12. Detail below is inconsistent with parapet wall details in Structural drawings. The bond beam is scheduled to be installed in the top course of cmu, so if the top cmu block is removed, where is the bond beam resolved?

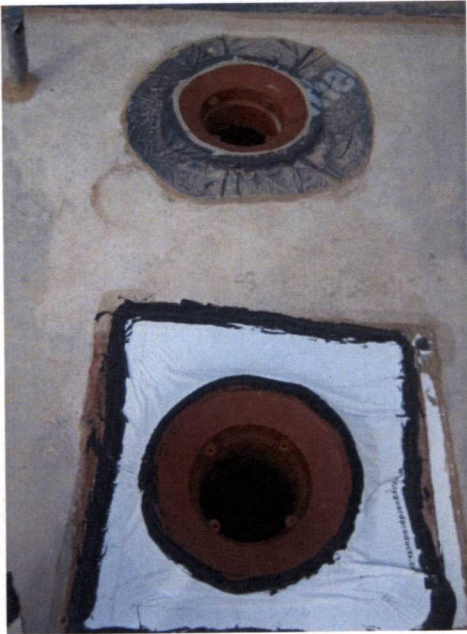
14. All drain openings must remain protected at all times.

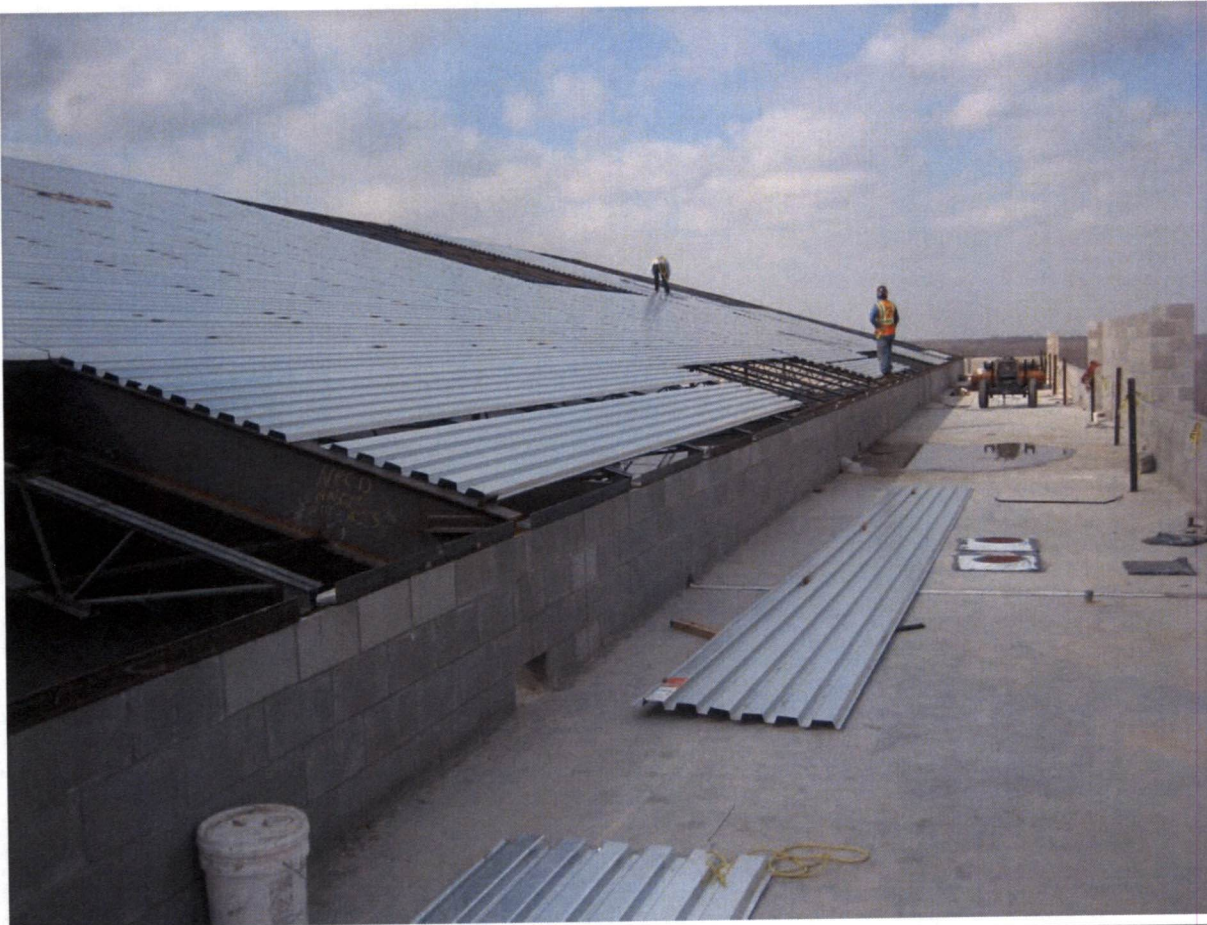
15. Roof installation. Brad Harris was notified that workers were wearing safety harnesses that were not tied off.
