## Exhibits for Arturo's Auto Repair/Hernandez Salvage Application

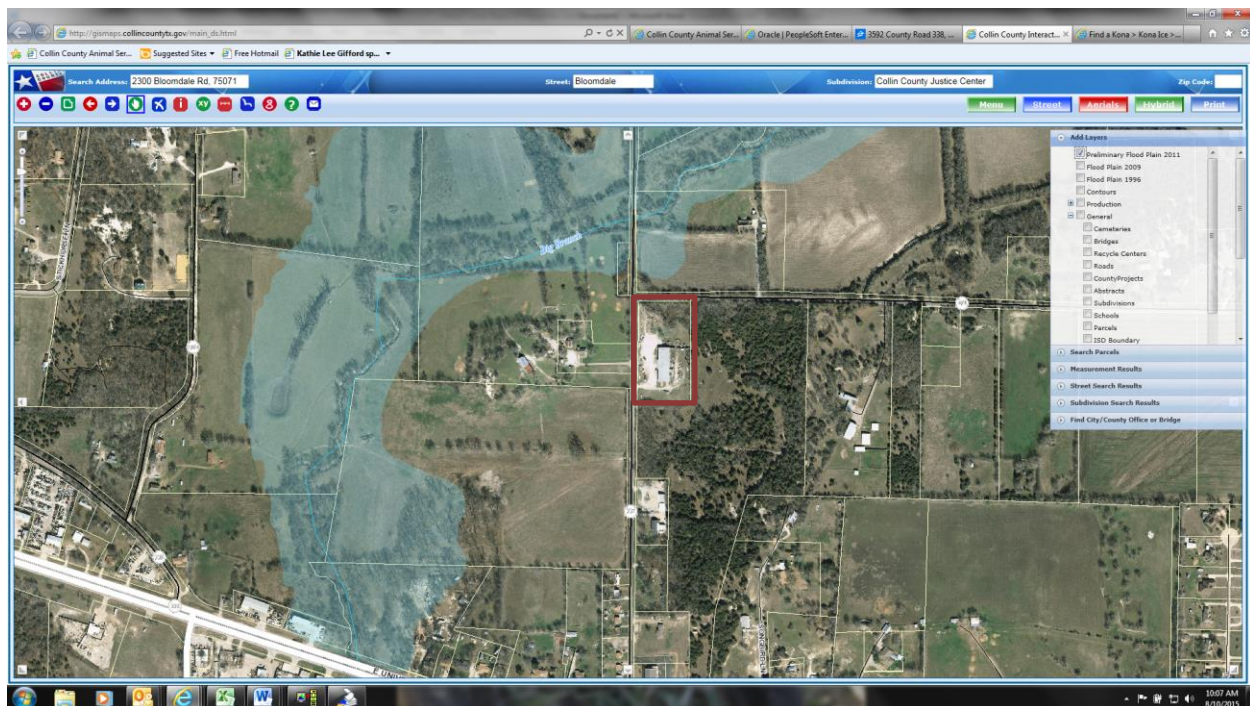
**Figure #2 – Location of the Flood Plain in reference to the subject property**

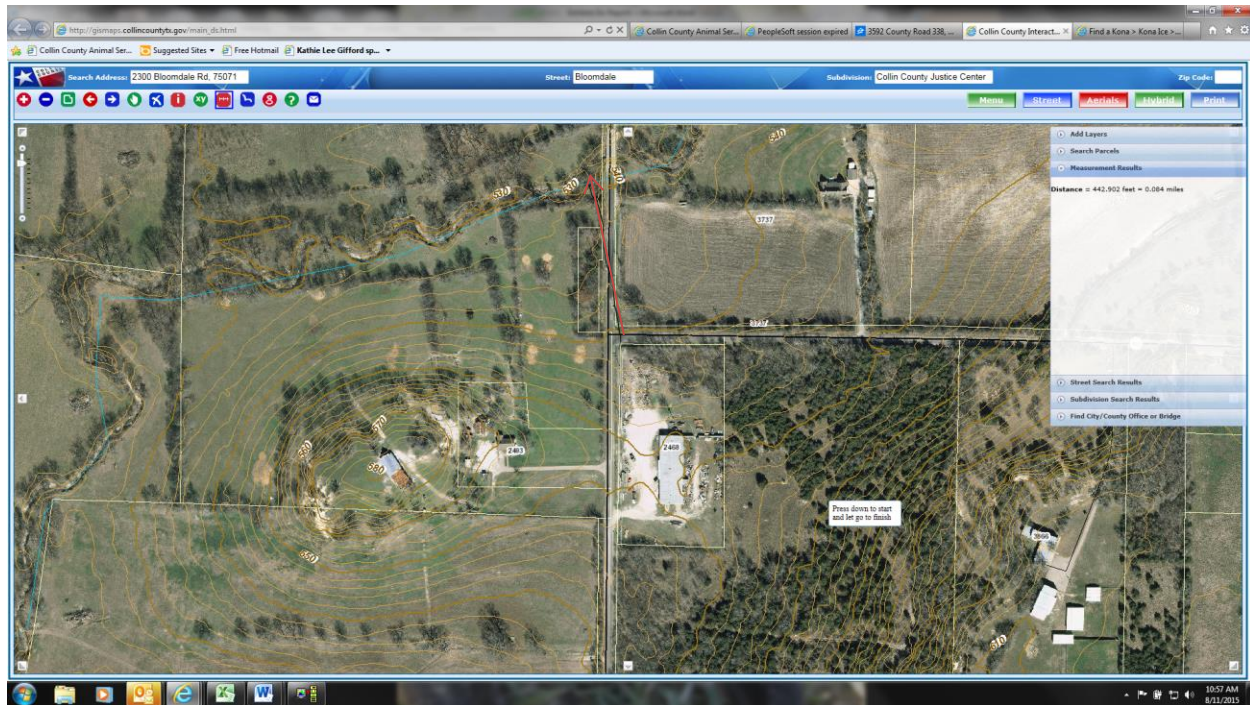
**Figure #3 – Approximate distance to Big Branch Creek is 442'**

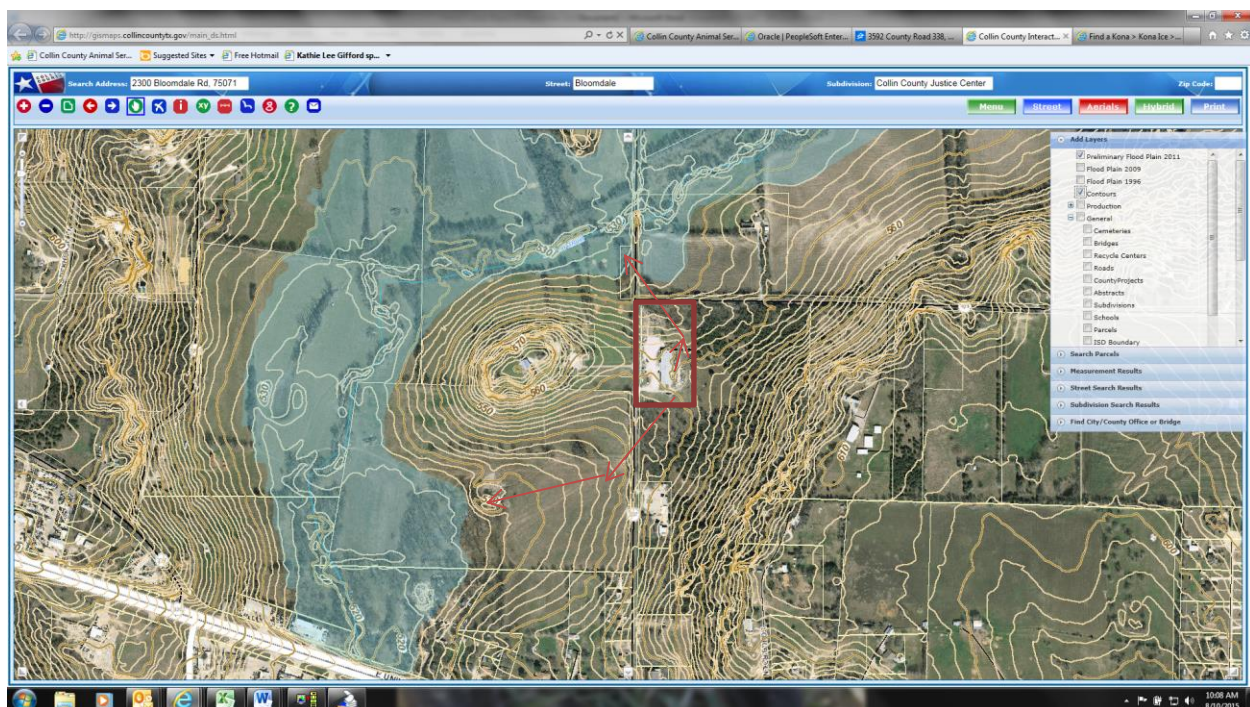
**Figure #4 – Contours surrounding the subject property and expected flow from property based on contours**

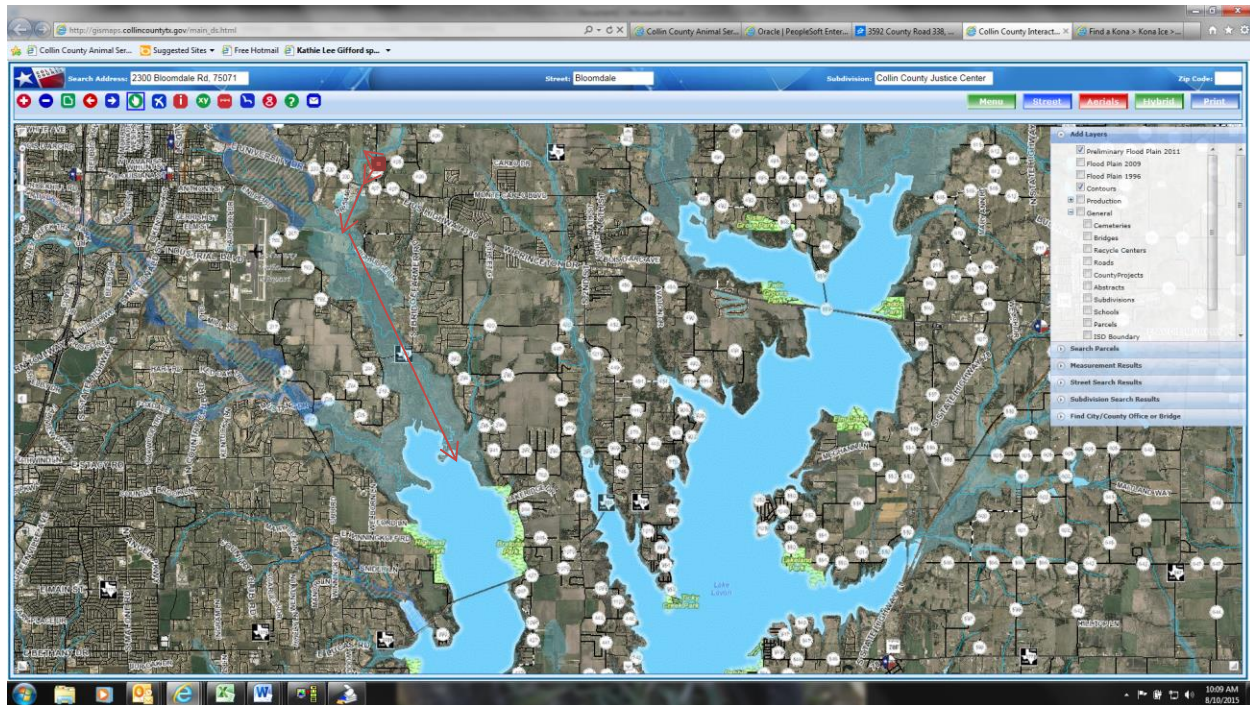
Figure #5 – Expanded view of downstream watershed area

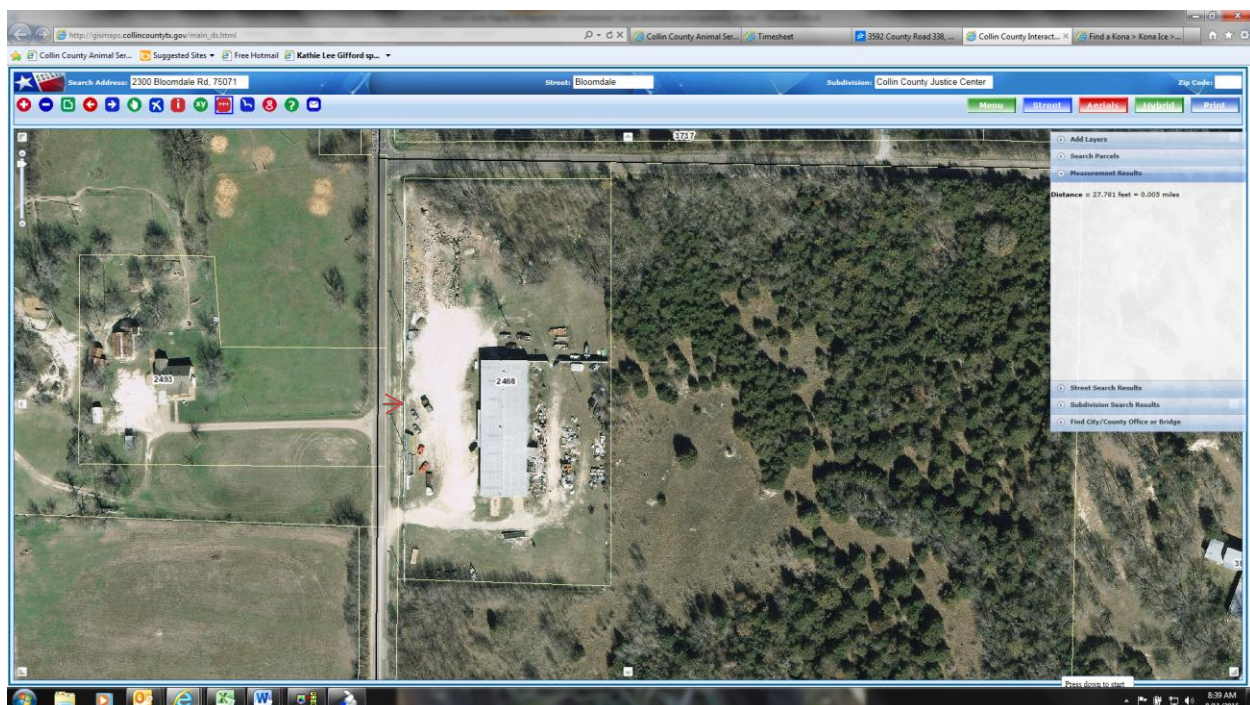
Figure #6 – Distance from ROW (centerline of the road) to the perimeter fencing is approximately 27'
