## **ADVANTAGE PROGRAM**

**Collin County Courthouse**  
**2100 Bloomdale Road,**  
**McKinney, TX 75071**

**Assessment Date: 1/7/2026**

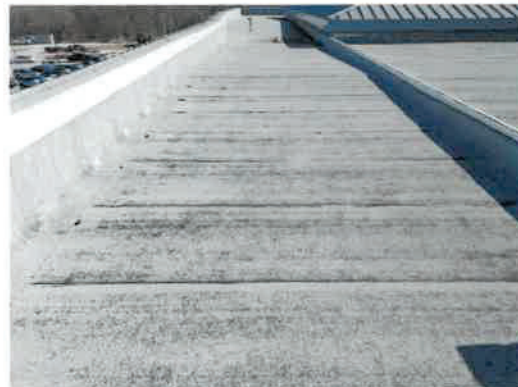
Roof: Roof A

Roof System: Modified  
Install Date: 2012 - Estimated  
Roof Deck: Metal  
Roof SF: 80,644

Elevation: 0  
Warr. Name & #: Unknown  
Warr. Exp. Date:  
Est. Service Life: 6-8

**Condition Assessment:** 70 - Serviceable

This roof is in serviceable condition and the recommended repairs should be performed to prevent the observed problems from becoming a critical condition.

**Recommended Action:** Repair

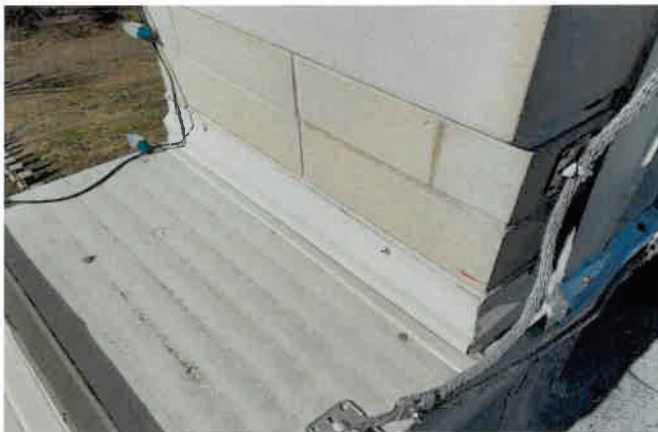
**NW2**

**Non-Warranty - Counterflashing - Sealant**

Separated and open sealant on the metal counterflashing. Remove the existing sealant. Clean, prime and apply new sealant.

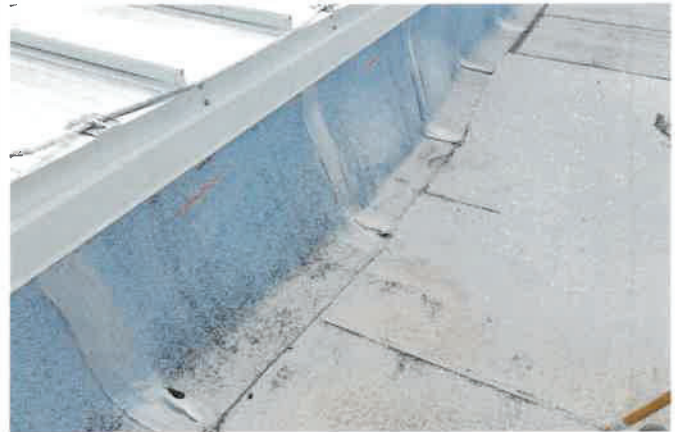
**NW16**

**Non-Warranty - Flashing - Blistered**

Blistered base flashing. Cut out blistered flashing membrane. Clean, prime and apply new flashing membrane

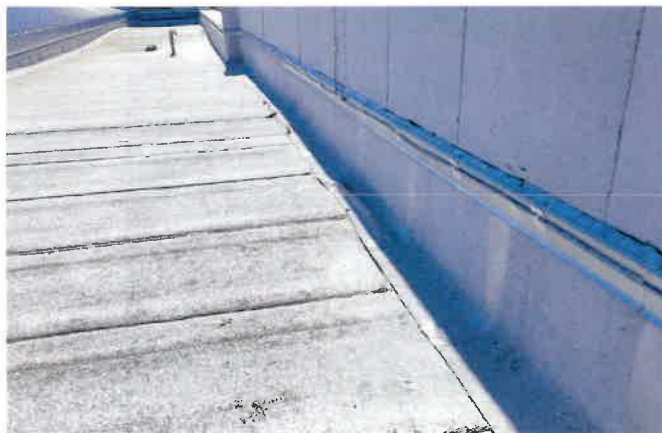
**NW81**

**Non-Warranty - Flashing - Racked and Wrinkled**

Racked and wrinkled base flashing. Cut out racked/wrinkled flashing membrane. Clean, prime and apply new flashing membrane.

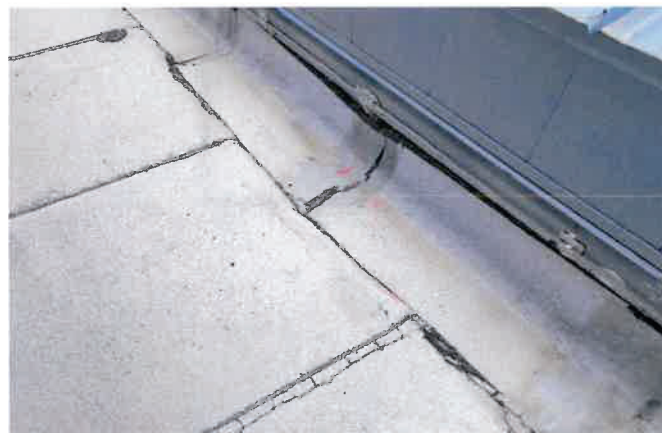
**NW60**

**Non-Warranty - Flashing - Slipping**

Slippage in flashing membrane. Cut out slipping base flashings. Clean, prime and apply new flashing membrane.

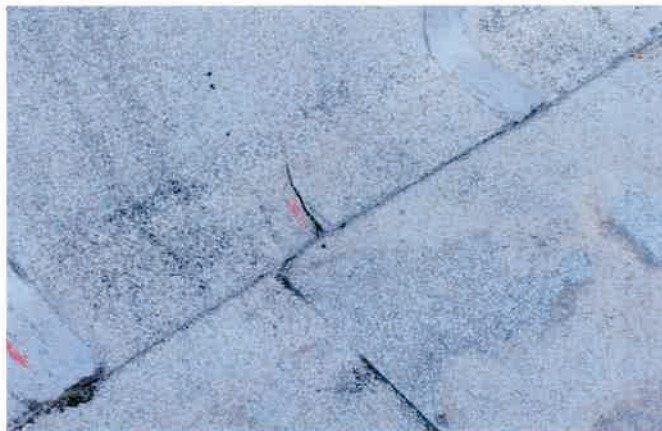
**NW13**

**Non-Warranty - Flashing Lap - Delaminated**

Delaminated and open lap in base flashing. Remove existing flashings. Clean, prime and apply new flashing membrane.

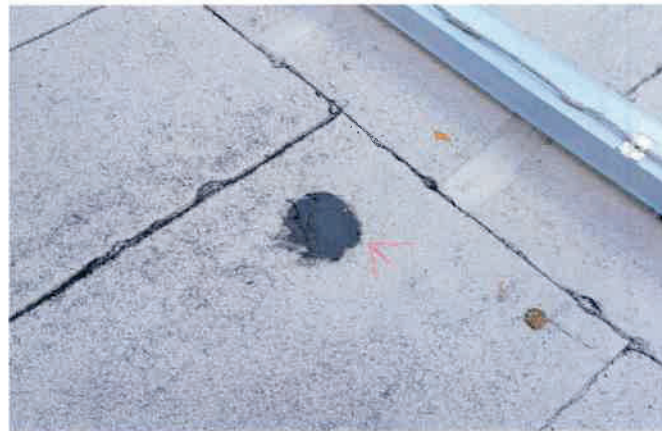
**NW50**

**Non-Warranty - Improper Repairs**

Improper repairs previously by others. Remove the existing improper repair materials. Clean, prime and apply proper materials; per industry standards.

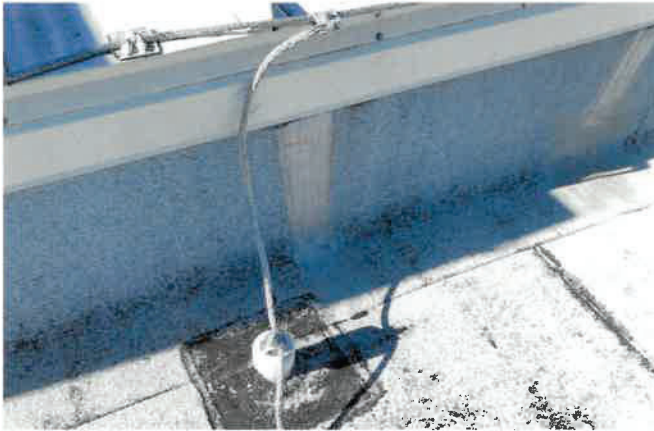
**NW21**

Non-Warranty - Liquid Flashing - Deteriorated

Damaged liquid flashing membrane. Clean prim, apply, new coating materials

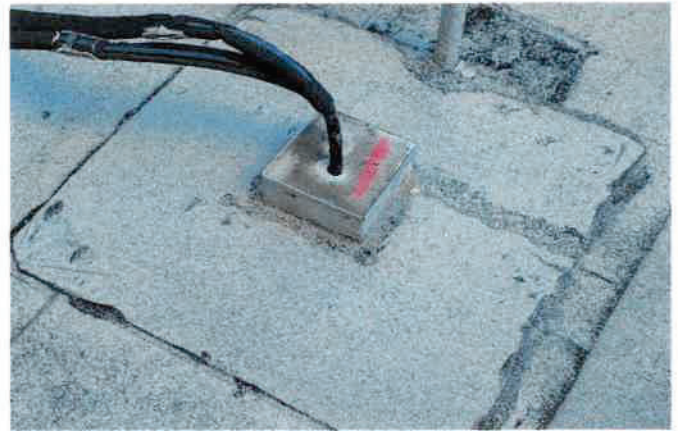
**NW1**

Non-Warranty - Pitch Pan - Fill

Settled and separated existing fill material in pitch pan. Remove the existing fill material and clean the pitch pan. Refill pitch pan with new fill material.

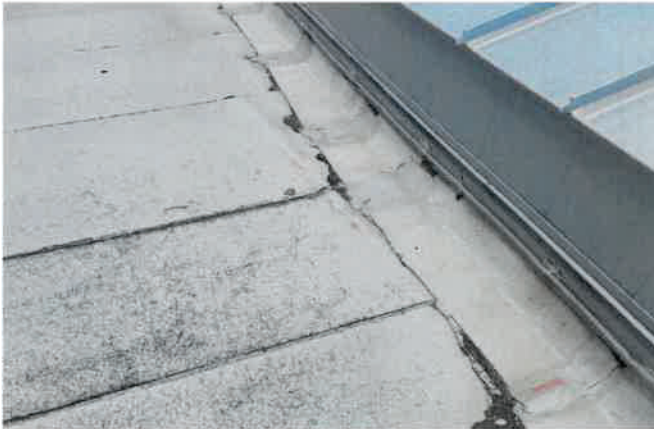
**NW15**

Non-Warranty - Roof Membrane - Blistered

Blistered roof membrane. Cut blistered roof membrane. Clean, prime, re-adhere and overlay with new roof membrane.

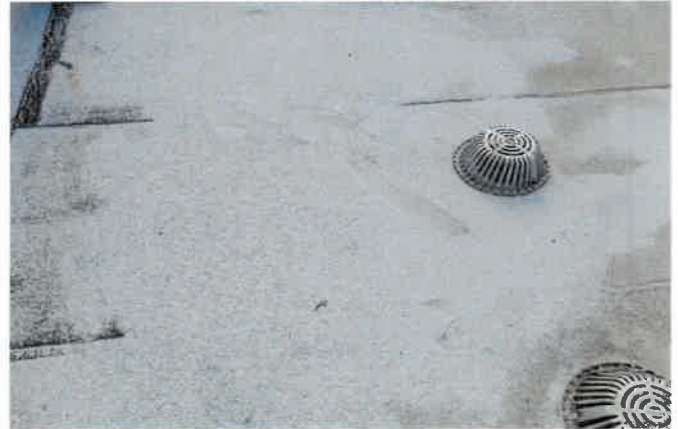
**BM1**

Building Maintenance - Debris

Debris on roof surface. Remove debris from roof.

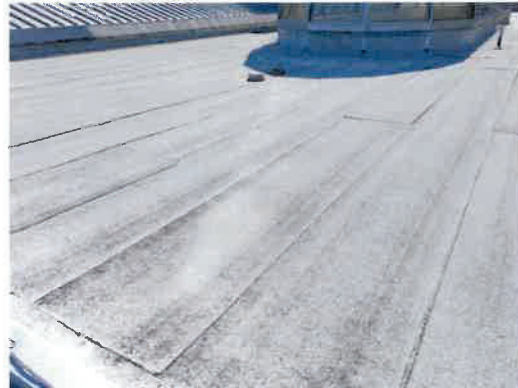
Roof: Roof B

Roof System: Modified  
Install Date: 2012 - Estimated  
Roof Deck: Metal  
Roof SF: 11,256

Elevation: 0  
Warr. Name & #: Unknown  
Warr. Exp. Date:  
Est. Service Life: 6-8

**Condition Assessment:** 70 - Serviceable

This roof is in serviceable condition and the recommended repairs should be performed to prevent the observed problems from becoming a critical condition.

**Recommended Action:** Repair

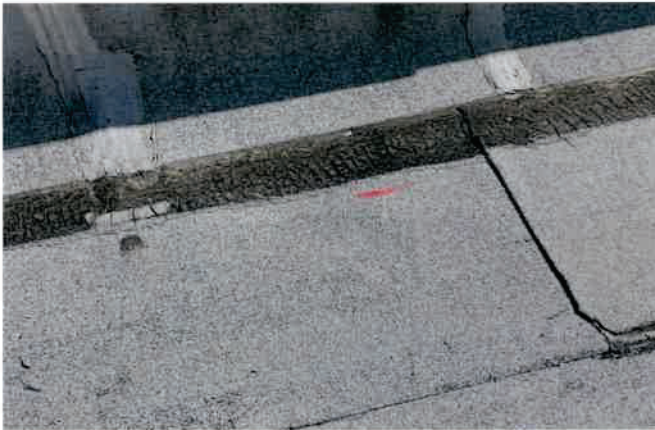
**NW16**

**Non-Warranty - Flashing - Blistered**

Blistered base flashing. Cut out blistered flashing membrane. Clean, prime and apply new flashing membrane

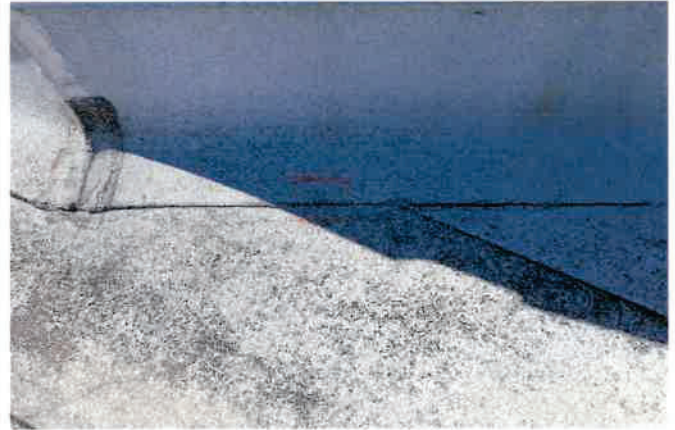
**NW13**

**Non-Warranty - Flashing Lap - Delaminated**

Delaminated and open lap in base flashing. Remove existing flashings. Clean, prime and apply new flashing membrane.

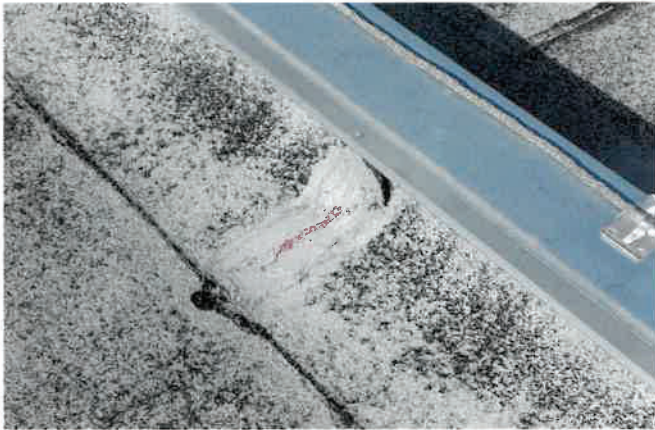
**NW21**

**Non-Warranty - Liquid Flashing - Deteriorated**

Damaged liquid flashing membrane. Clean prim, apply, new coating materials

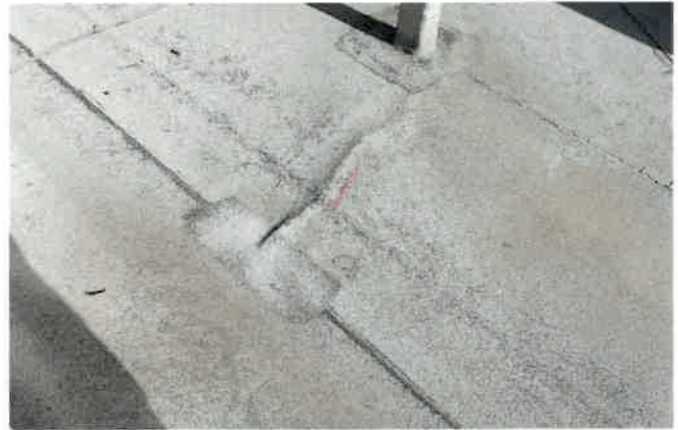
**NW92**

**Non-Warranty - Roof Membrane - Alligatored**

Weathered and alligatored capsheet roof membrane. This condition appears to be watertight. No repairs are needed at this time. Continue to monitor this condition through periodic inspections.

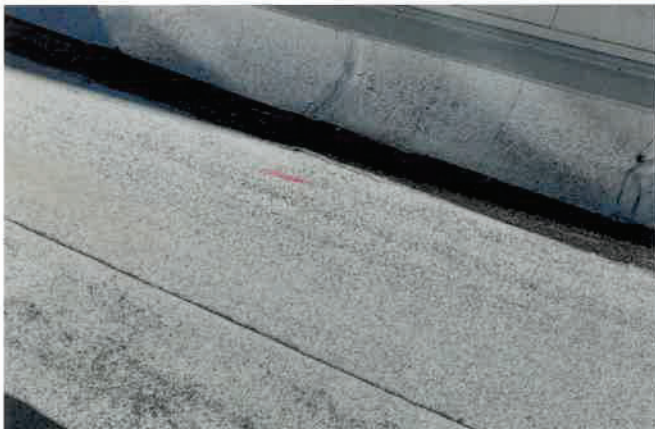
**NW15**

**Non-Warranty - Roof Membrane - Blistered**

Blistered roof membrane. Cut blistered roof membrane. Clean, prime, re-adhere and overlay with new roof membrane.

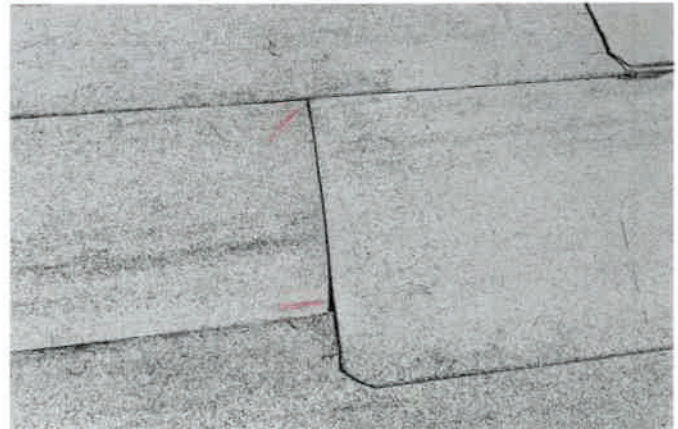
**NW17**

**Non-Warranty - Seam Delaminated**

Delaminated and open seam in the roof membrane. Clean, prime, re-weld and overlay area with new roof membrane.

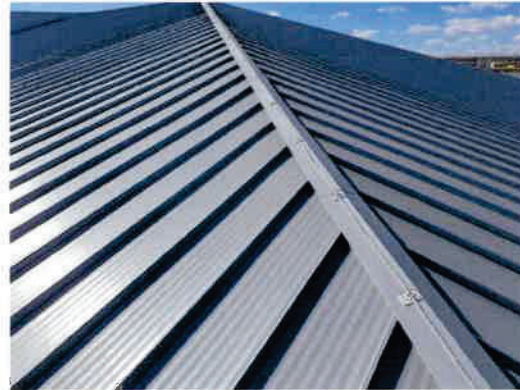
Roof: Roof C

Roof System: Metal Panel  
Install Date: 2012 - Estimated  
Roof Deck: Plywood  
Roof SF: 0

Elevation: 0  
Warr. Name & #: Unknown  
Warr. Exp. Date:  
Est. Service Life: 16-18

**Condition Assessment:** 85 - Good

This roof is in good condition and the recommended repairs should be performed to prevent the observed problems from becoming a critical condition.

**Recommended Action:** Repair

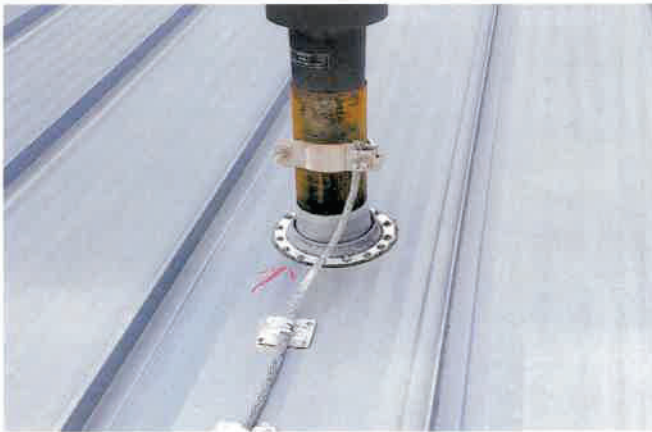
**NW20**

**Non-Warranty - Penetration Sealant - Separated**

Separated and open sealant on base of roof penetration. Remove the existing sealant. Clean, prime and apply new sealant.

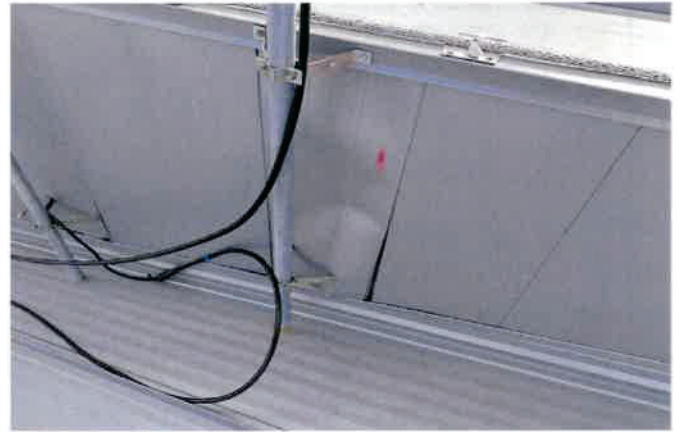
**BM12**

**Building Maintenance - Wall - Damaged**

Damaged exterior wall. We recommend that the building owner contact the appropriate contractor to address this condition.

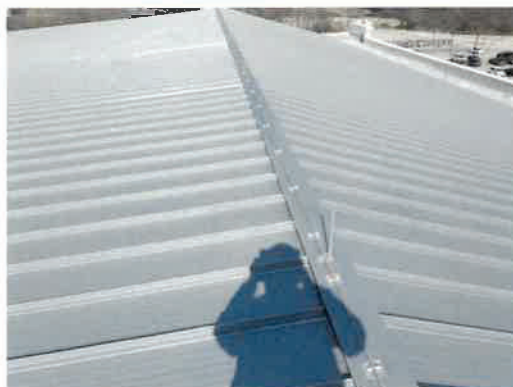
Roof: Roof D

Roof System: Metal Panel  
Install Date: 2012 - Estimated  
Roof Deck: Plywood  
Roof SF: 0

Elevation: 0  
Warr. Name & #: Unknown  
Warr. Exp. Date:  
Est. Service Life: 16-18

**Condition Assessment:** 85 - Good

This roof is in good condition and the recommended repairs should be performed to prevent the observed problems from becoming a critical condition.

**Recommended Action:** Repair

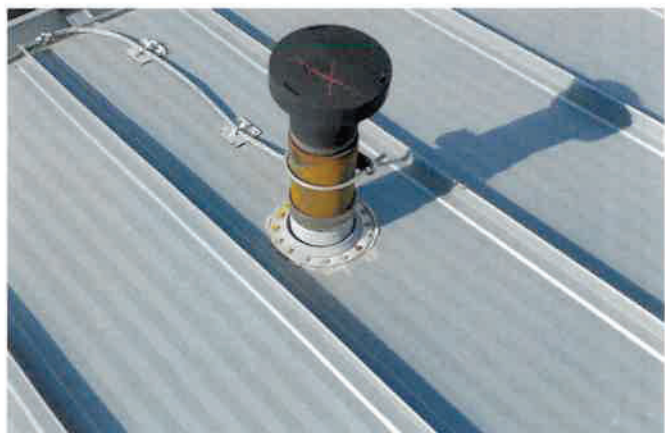
**NW20**

**Non-Warranty - Penetration Sealant - Separated**

Separated and open sealant on base of roof penetration. Remove the existing sealant. Clean, prime and apply new sealant.

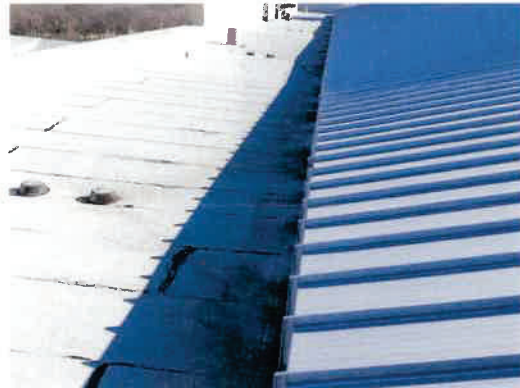
Roof: Roof E

Roof System: Modified  
Install Date: 2006 - Estimated  
Roof Deck: Metal  
Roof SF: 8,077

Elevation: 0  
Warr. Name & #: Unknown  
Warr. Exp. Date:  
Est. Service Life: 3-5

**Condition Assessment:** 70 - Serviceable

This roof is in serviceable condition and the recommended repairs should be performed to prevent the observed problems from becoming a critical condition.

**Recommended Action:** Repair

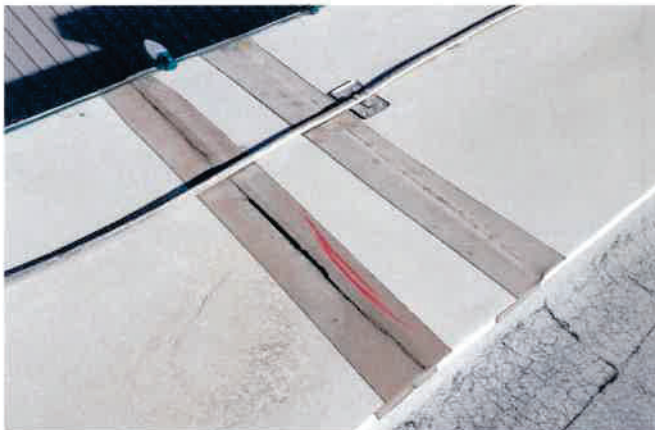
**NW30**

**Non-Warranty - Coping Cap - Sealant**

Separated and open sealant on seams in the metal coping cap. Remove the existing sealant. Clean, prime and apply new sealant.

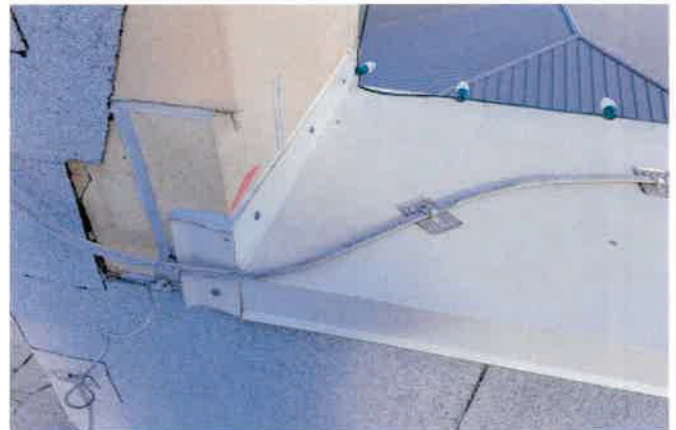
**NW2**

**Non-Warranty - Counterflashing - Sealant**

Separated and open sealant on the metal counterflashing. Remove the existing sealant. Clean, prime and apply new sealant.

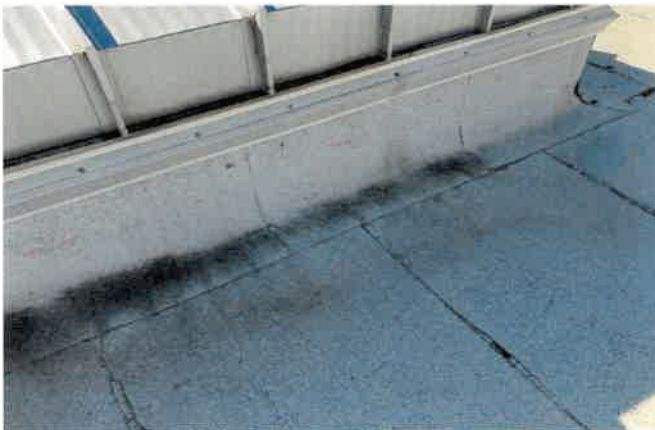
**NW16**

**Non-Warranty - Flashing - Blistered**

Blistered base flashing. Cut out blistered flashing membrane. Clean, prime and apply new flashing membrane

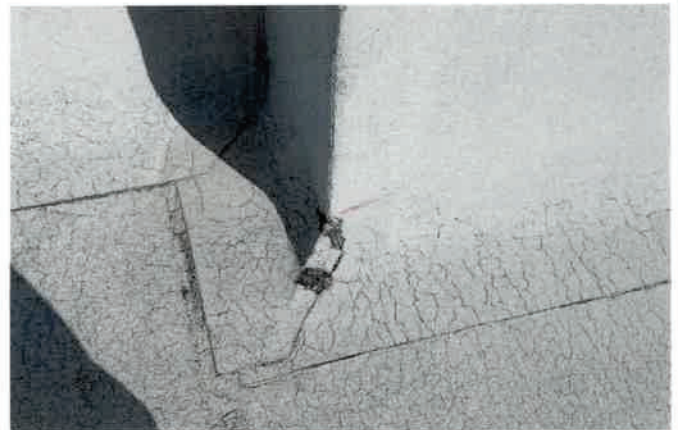
**NW13**

**Non-Warranty - Flashing Lap - Delaminated**

Delaminated and open lap in base flashing. Remove existing flashings. Clean, prime and apply new flashing membrane.

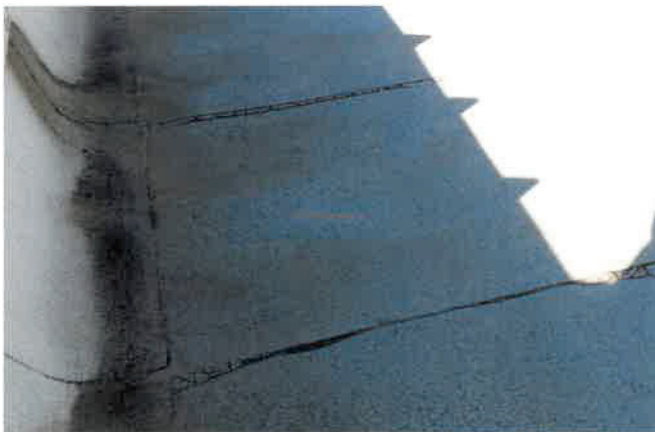
**NW15**

**Non-Warranty - Roof Membrane - Blistered**

Blistered roof membrane. Cut blistered roof membrane. Clean, prime, re-adhere and overlay with new roof membrane.

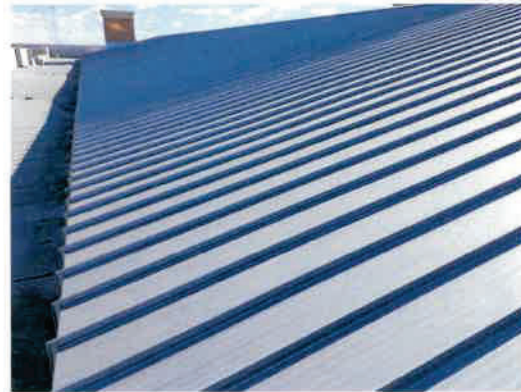
Roof: Roof F

Roof System: Metal Panel.  
Install Date: 2006 - Estimated  
Roof Deck: Plywood  
Roof SF: 0

Elevation: 0  
Warr. Name & #: Unknown  
Warr. Exp. Date:  
Est. Service Life: 11-13

**Condition Assessment:** 85 - Good

This roof is in good condition and the recommended repairs should be performed to prevent the observed problems from becoming a critical condition.

**Recommended Action:** Repair

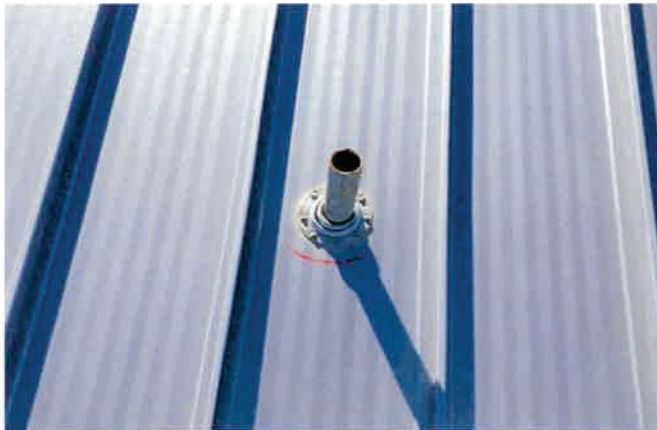
**NW4**

**Non-Warranty - Clamping Ring - Sealant**

Separated and open sealant on clamping ring. Remove existing sealant. Clean, prime and apply new sealant.

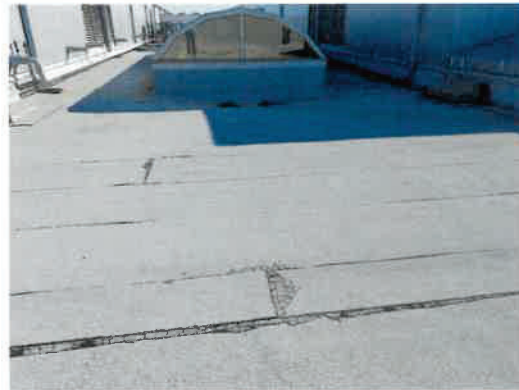
Roof: Roof G

Roof System: Modified  
Install Date: 2006 - Estimated  
Roof Deck: Metal  
Roof SF: 12,240

Elevation: 0  
Warr. Name & #: Unknown  
Warr. Exp. Date:  
Est. Service Life: 3-5

**Condition Assessment:** 70 - Serviceable

This roof is in serviceable condition and the recommended repairs should be performed to prevent the observed problems from becoming a critical condition.

**Recommended Action:** Repair

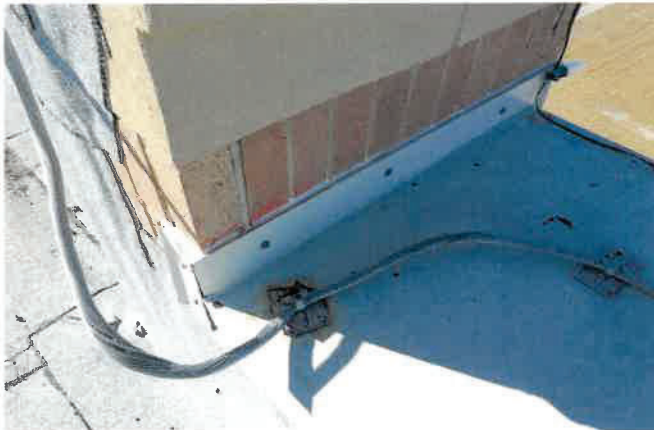
**NW2**

**Non-Warranty - Counterflashing - Sealant**

Separated and open sealant on the metal counterflashing. Remove the existing sealant. Clean, prime and apply new sealant.

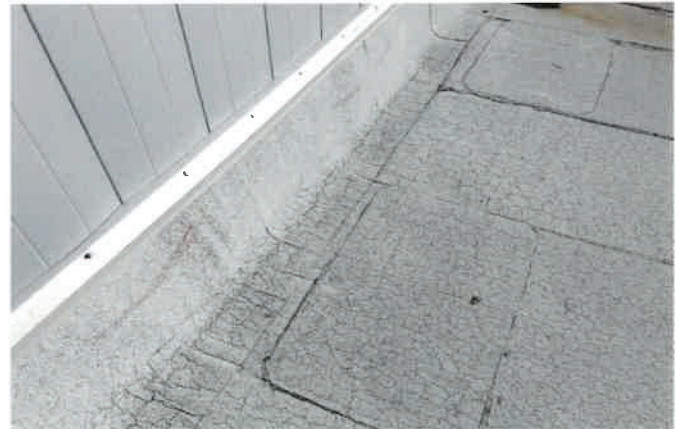
**NW16**

**Non-Warranty - Flashing - Blistered**

Blistered base flashing. Cut out blistered flashing membrane. Clean, prime and apply new flashing membrane

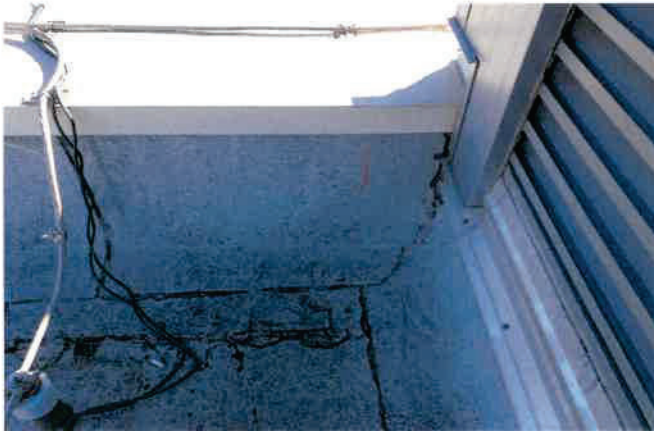
**NW13**

**Non-Warranty - Flashing Lap - Delaminated**

Delaminated and open lap in base flashing. Remove existing flashings. Clean, prime and apply new flashing membrane.

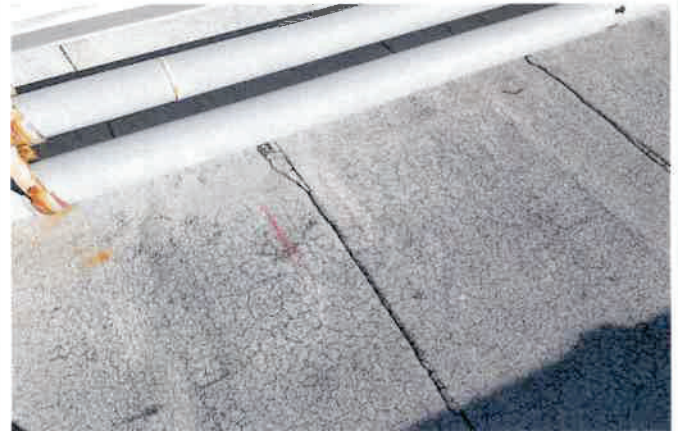
**NW15**

**Non-Warranty - Roof Membrane - Blistered**

Blistered roof membrane. Cut blistered roof membrane. Clean, prime, re-adhere and overlay with new roof membrane.

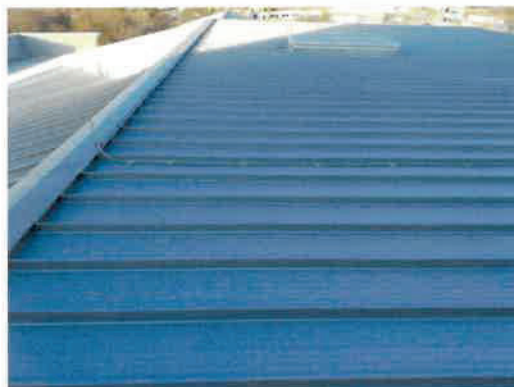
Roof: Roof H

Roof System: Metal Panel  
Install Date: 2006 - Estimated  
Roof Deck: Metal  
Roof SF: 0

Elevation: 0  
Warr. Name & #: Unknown  
Warr. Exp. Date:  
Est. Service Life: 11-13

**Condition Assessment:** 70 - Serviceable

This roof is in good condition and the recommended repairs should be performed to prevent the observed problems from becoming a critical condition.

**Recommended Action:** Repair

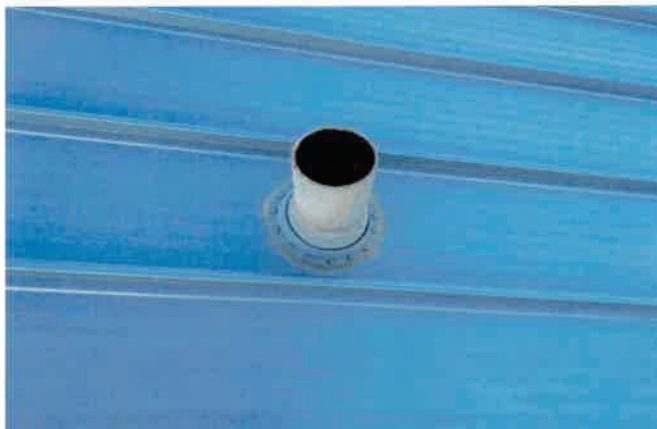
**NW4**

**Non-Warranty - Clamping Ring - Sealant**

Separated and open sealant on clamping ring. Remove existing sealant. Clean, prime and apply new sealant.

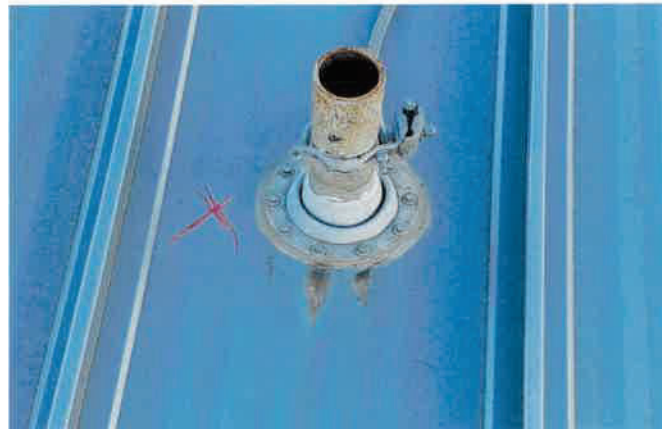
**NW20**

**Non-Warranty - Penetration Sealant - Separated**

Separated and open sealant on base of roof penetration. Remove the existing sealant. Clean, prime and apply new sealant.

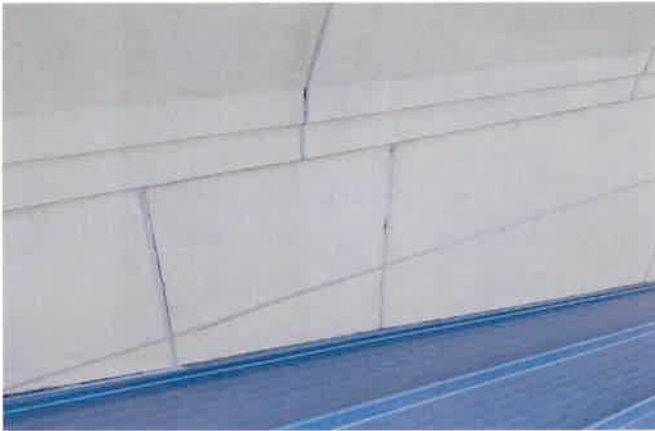
**BM2**

Building Maintenance - Control Joint Sealant

Separated and open sealant in wall control joint **above roof level**. Remove existing sealant. Clean, prime, install backer rod insulation and apply new sealant.

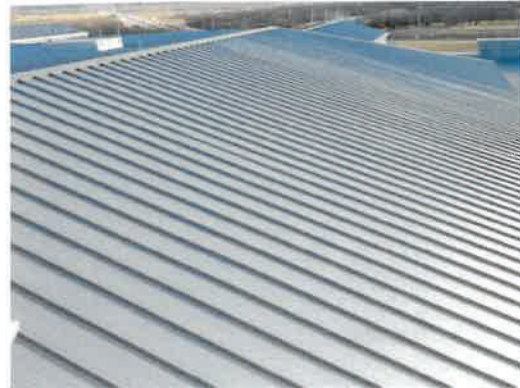
Roof: Roof I

Roof System: Metal Panel  
Install Date: 2006 - Estimated  
Roof Deck: Metal  
Roof SF: 0

Elevation: 0  
Warr. Name & #: Unknown  
Warr. Exp. Date:  
Est. Service Life: 11-13

**Condition Assessment:** 70 - Serviceable

This roof is in serviceable condition and the recommended repairs should be performed to prevent the observed problems from becoming a critical condition.

**Recommended Action:** Repair

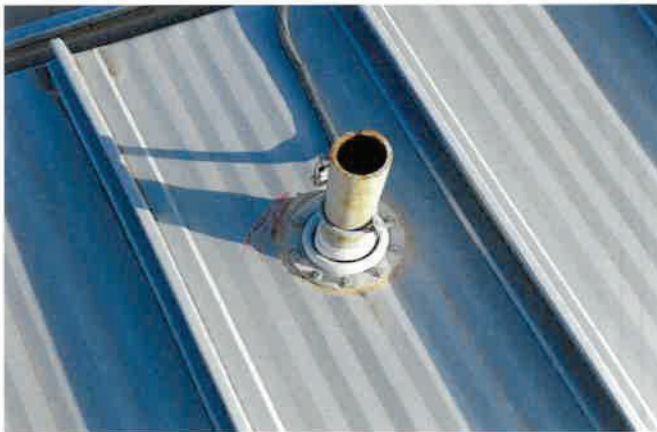
**NW20**

**Non-Warranty - Penetration Sealant - Separated**

Separated and open sealant on base of roof penetration. Remove the existing sealant. Clean, prime and apply new sealant.

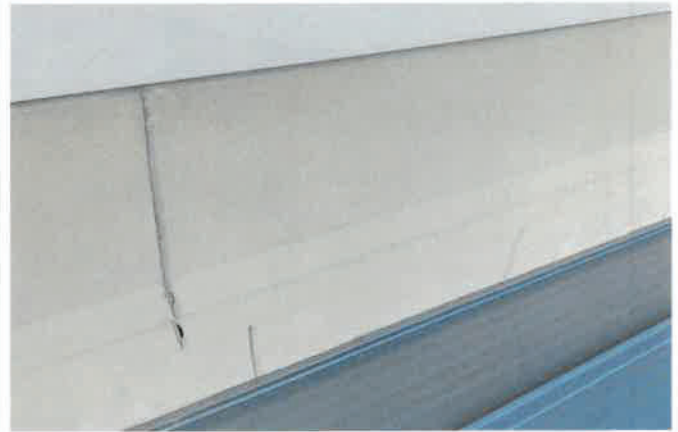
**BM2**

**Building Maintenance - Control Joint Sealant**

Separated and open sealant in wall control joint **above roof level**. Remove existing sealant. Clean, prime, install backer rod insulation and apply new sealant.

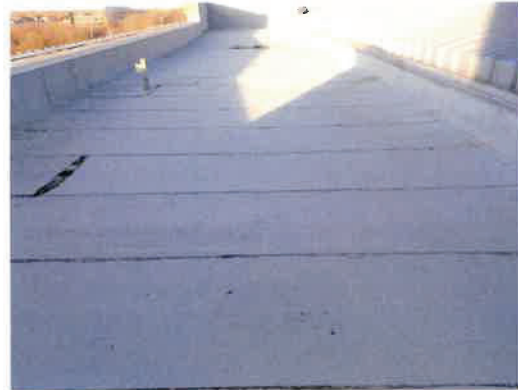
Roof: Roof J

Roof System: Modified  
Install Date: 2006 - Estimated  
Roof Deck: Metal  
Roof SF: 3,404

Elevation: 0  
Warr. Name & #: Unknown  
Warr. Exp. Date:  
Est. Service Life: 3-5

**Condition Assessment:** 70 - Serviceable

This roof is in serviceable condition and the recommended repairs should be performed to prevent the observed problems from becoming a critical condition.

**Recommended Action:** Repair

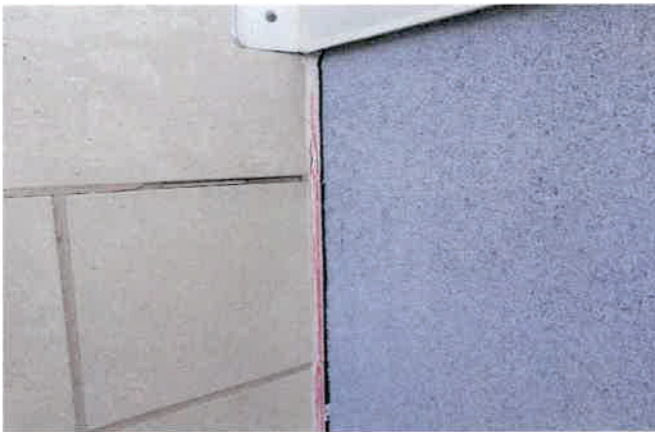
**NW2**

**Non-Warranty - Counterflashing - Sealant**

Separated and open sealant on the metal counterflashing. Remove the existing sealant. Clean, prime and apply new sealant.

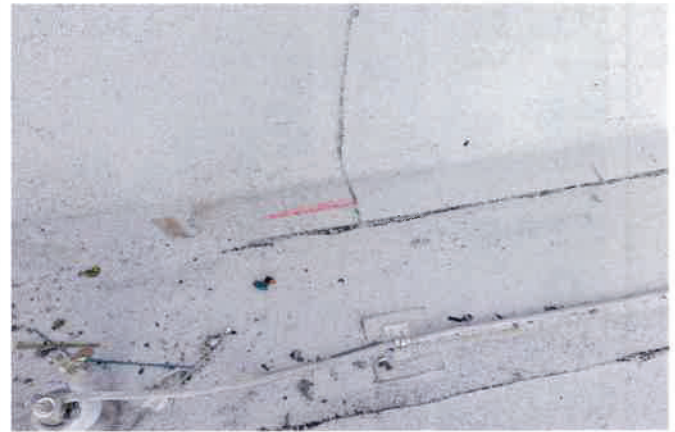
**NW16**

**Non-Warranty - Flashing - Blistered**

Blistered base flashing. Cut out blistered flashing membrane. Clean, prime and apply new flashing membrane

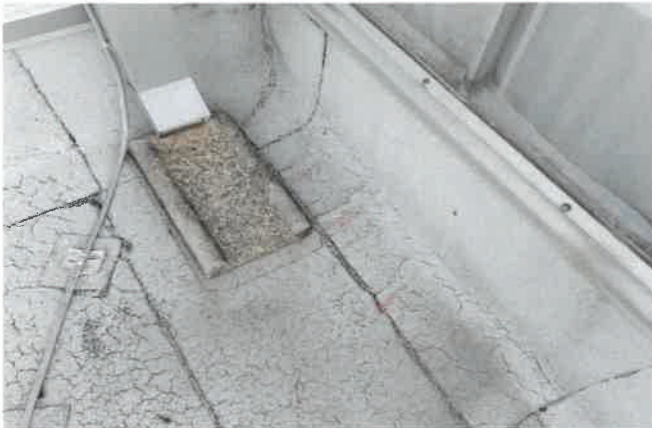
**NW13**

**Non-Warranty - Flashing Lap - Delaminated**

Delaminated and open lap in base flashing. Remove existing flashings. Clean, prime and apply new flashing membrane.

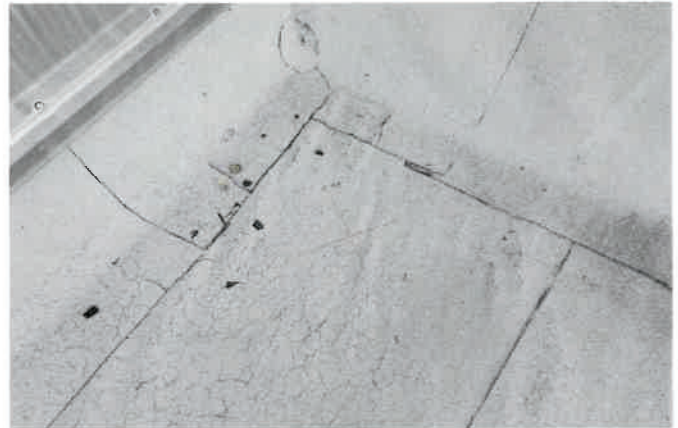
**NW92**

**Non-Warranty - Roof Membrane - Alligatored**

Weathered and alligatored capsheet roof membrane. This condition appears to be watertight. No repairs are needed at this time. Continue to monitor this condition through periodic inspections.

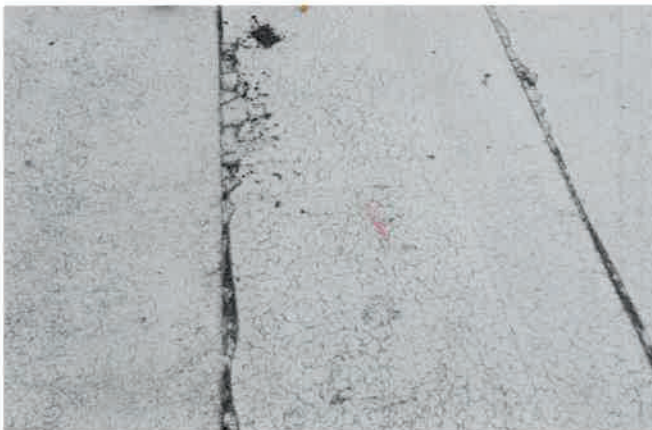
**NW15**

**Non-Warranty - Roof Membrane - Blistered**

Blistered roof membrane. Cut blistered roof membrane. Clean, prime, re-adhere and overlay with new roof membrane.

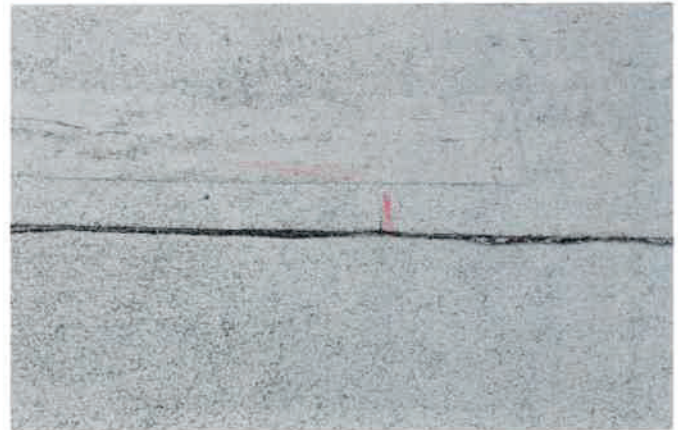
**NW17**

**Non-Warranty - Seam Delaminated**

Delaminated and open seam in the roof membrane. Clean, prime, re-weld and overlay area with new roof membrane.

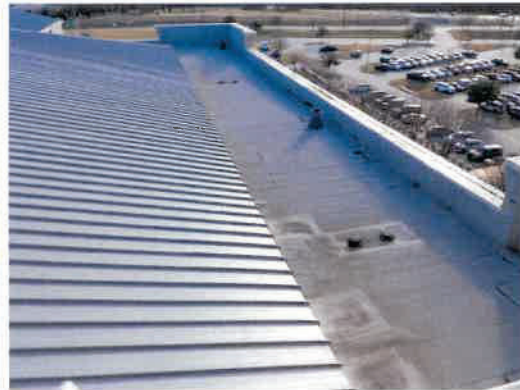
Roof: Roof K

Roof System: Modified  
Install Date: 2006 - Estimated  
Roof Deck: Metal  
Roof SF: 3,404

Elevation: 0  
Warr. Name & #: Unknown  
Warr. Exp. Date:  
Est. Service Life: 3-5

**Condition Assessment:** 70 - Serviceable

This roof is in serviceable condition and the recommended repairs should be performed to prevent the observed problems from becoming a critical condition.

**Recommended Action:** Repair

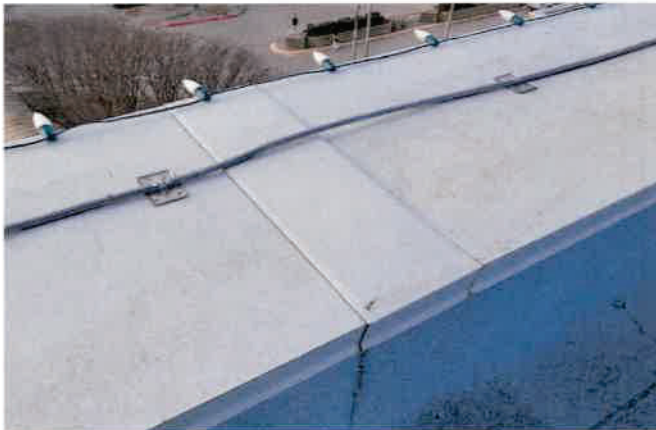
**NW30**

**Non-Warranty - Coping Cap - Sealant**

Separated and open sealant on seams in the metal coping cap. Remove the existing sealant. Clean, prime and apply new sealant. All coping in this roof section

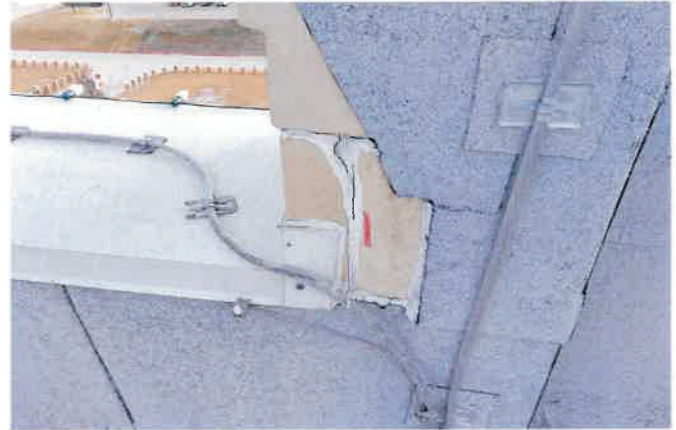
**NW2**

**Non-Warranty - Counterflashing - Sealant**

Separated and open sealant on the metal counterflashing. Remove the existing sealant. Clean, prime and apply new sealant.

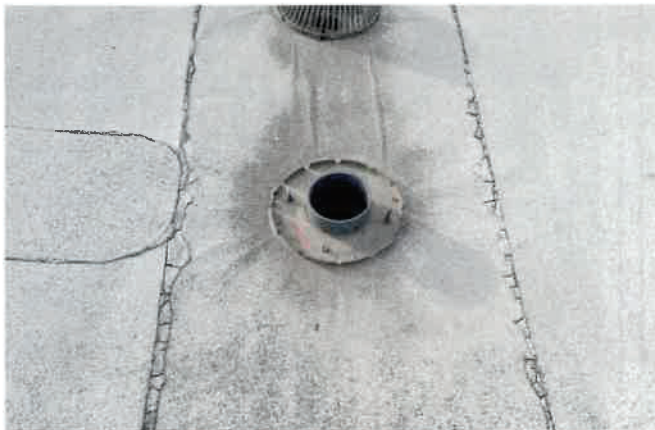
**NW7**

Non-Warranty - Drain Strainer

Broken/missing drain strainer. Furnish and install new drain strainer.

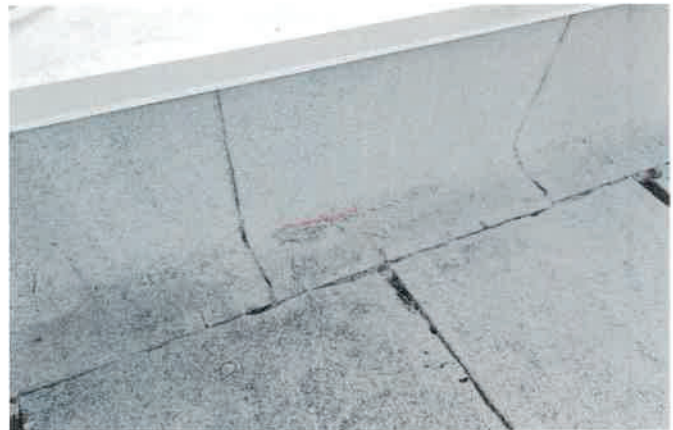
**NW16**

Non-Warranty - Flashing - Blistered

Blistered base flashing. Cut out blistered flashing membrane. Clean, prime and apply new flashing membrane

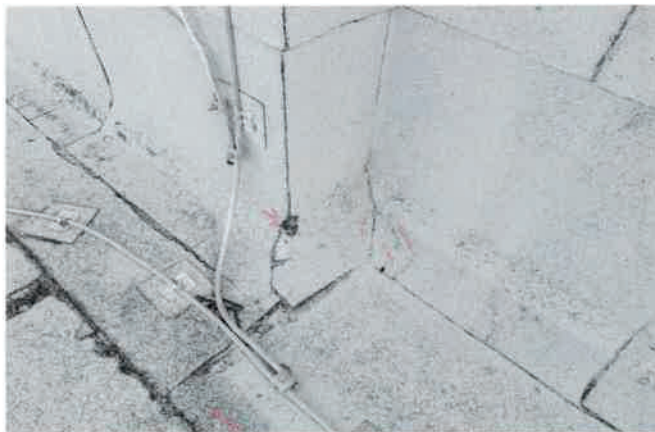
**NW12**

Non-Warranty - Flashing - Delaminated

Delaminated and open flashings. Remove existing flashings. Clean, prime and apply new flashing membrane.

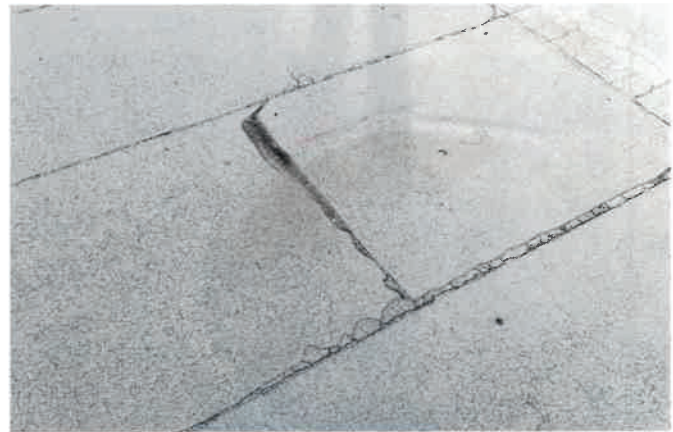
**NW92**

Non-Warranty - Roof Membrane - Alligatored

Weathered and alligatored capsheet roof membrane. This condition appears to be watertight. No repairs are needed at this time. Continue to monitor this condition through periodic inspections.

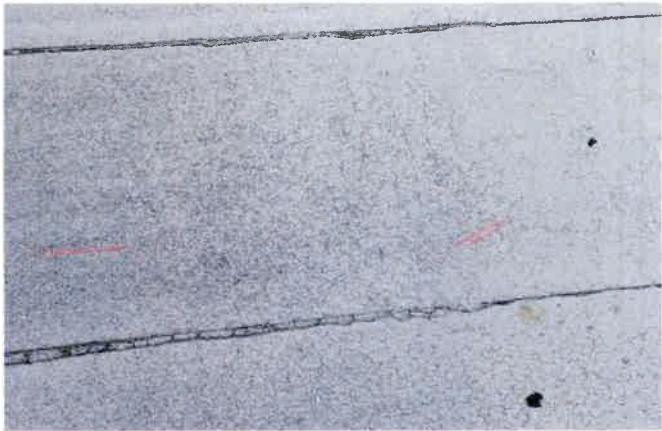
**NW15**

**Non-Warranty - Roof Membrane - Blistered**

Blistered roof membrane. Cut blistered roof membrane. Clean, prime, re-adhere and overlay with new roof membrane.

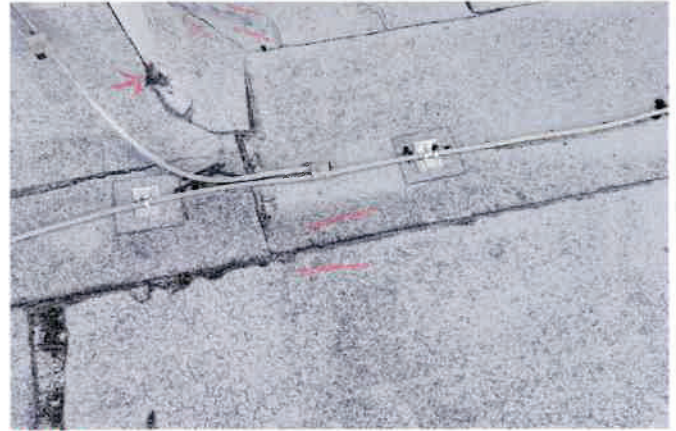
**NW17**

**Non-Warranty - Seam Delaminated**

Delaminated and open seam in the roof membrane. Clean, prime, re-weld and overlay area with new roof membrane.

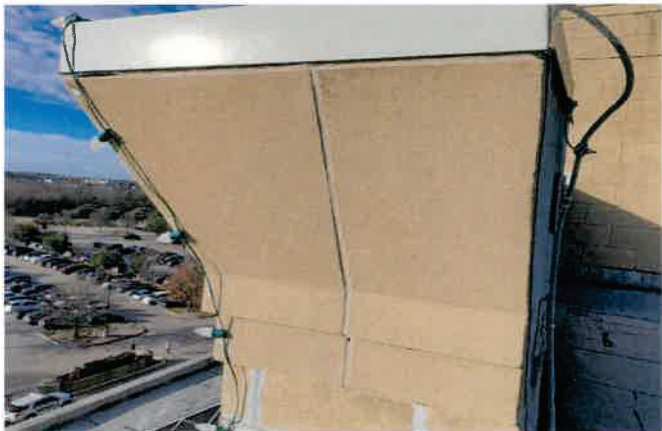
**BM2**

**Building Maintenance - Control Joint Sealant**

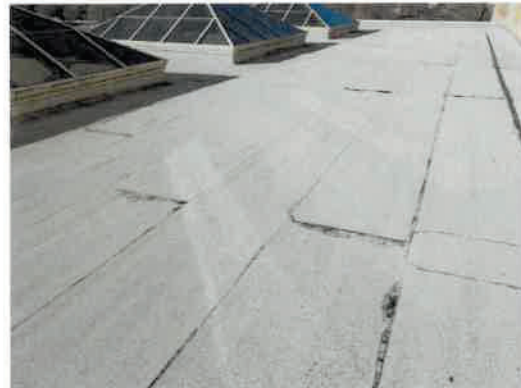
Roof: Roof L

Roof System: Modified  
Install Date: 2006 - Estimated  
Roof Deck: Metal  
Roof SF: 6,188

Elevation: 0  
Warr. Name & #: Unknown  
Warr. Exp. Date:  
Est. Service Life: 3-5

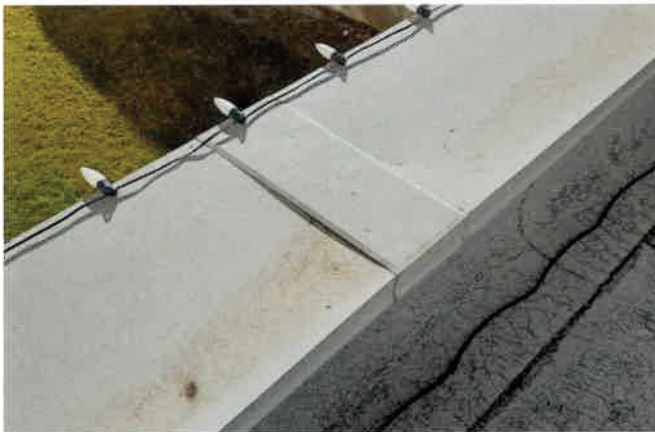
**NW30**

**Non-Warranty - Coping Cap - Sealant**

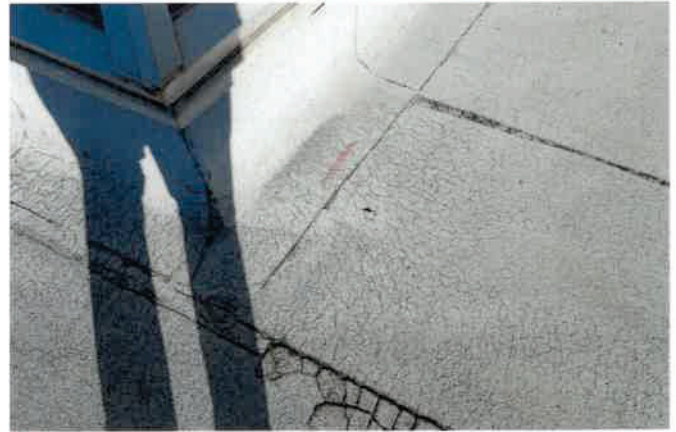
**NW16**

**Non-Warranty - Flashing - Blistered**

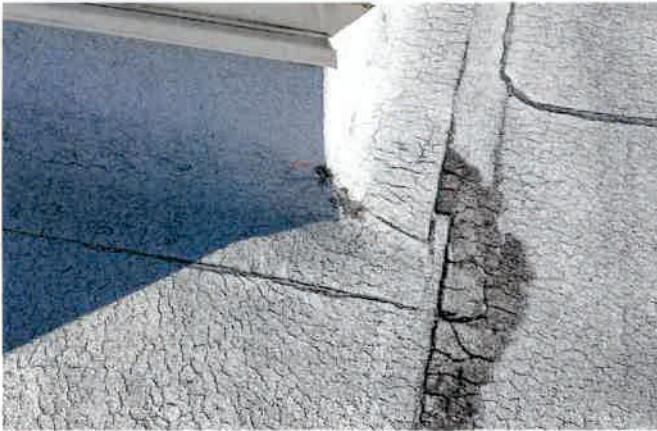
**NW13**

**Non-Warranty - Flashing Lap - Delaminated**

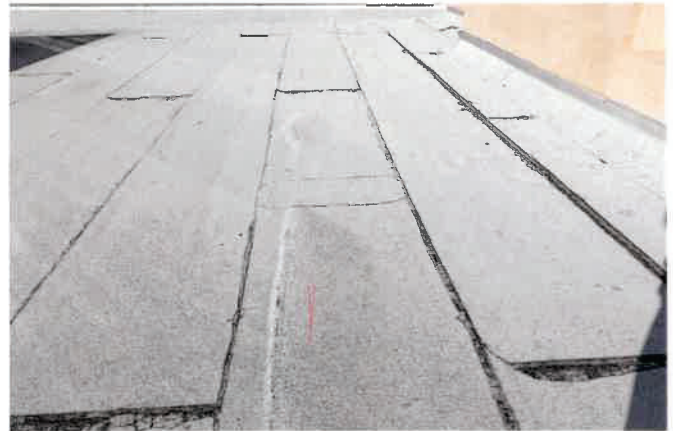
**NW15**

**Non-Warranty - Roof Membrane - Blistered**

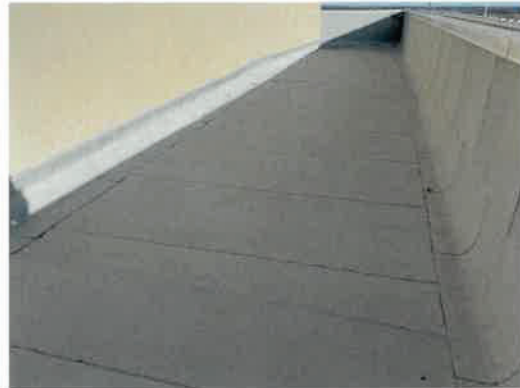
Roof: Roof M

Roof System: Modified  
Install Date: 2006 - Estimated  
Roof Deck: Metal  
Roof SF: 7,208

Elevation: 0  
Warr. Name & #: Unknown  
Warr. Exp. Date:  
Est. Service Life: 3-5

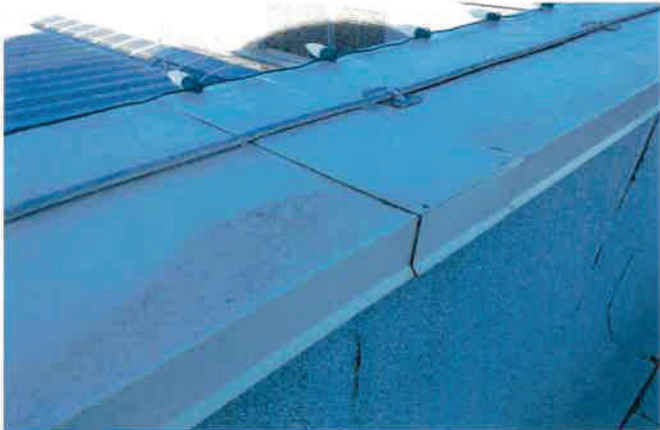
**NW30**

**Non-Warranty - Coping Cap - Sealant**

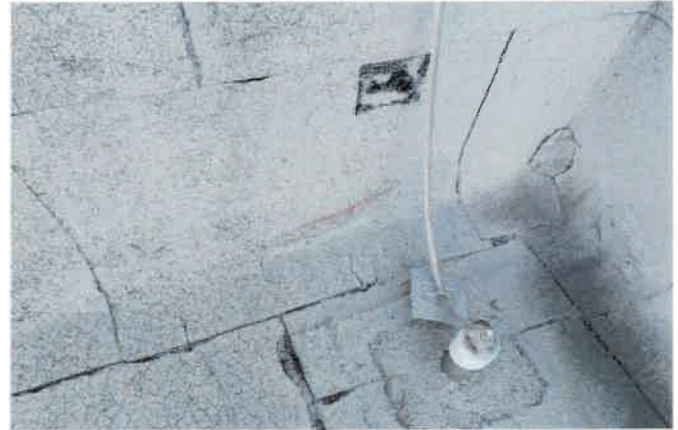
**NW16**

**Non-Warranty - Flashing - Blistered**

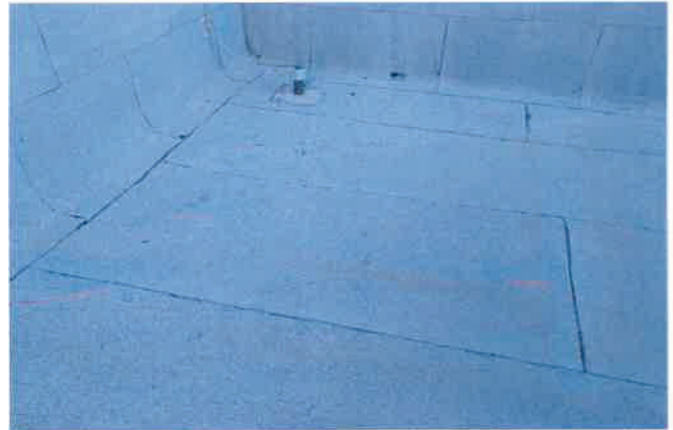
**NW15**

**Non-Warranty - Roof Membrane - Blistered**

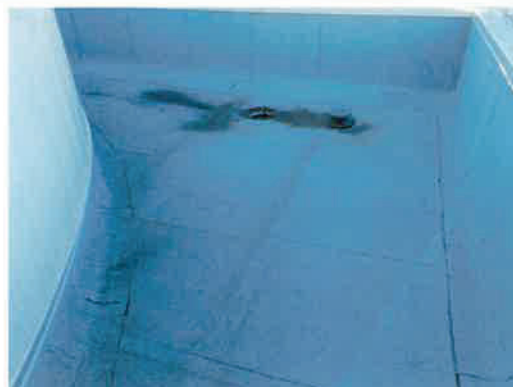
Roof: Roof N

Roof System: Modified  
Install Date: 2006 - Estimated  
Roof Deck: Metal  
Roof SF: 2,704

Elevation: 0  
Warr. Name & #: Unknown  
Warr. Exp. Date:  
Est. Service Life: 3-5
