## **ADVANTAGE PROGRAM**

**Collin County Courthouse**  
**2100 Bloomdale Road,**  
**McKinney, TX 75071**

**Assessment Date: 1/7/2026**

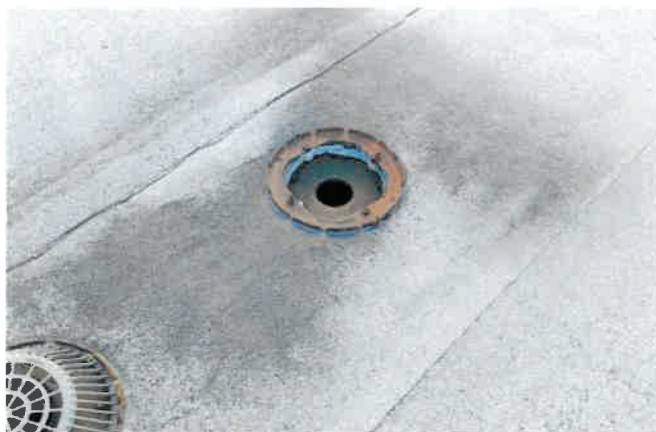
**NW7**

**Non-Warranty - Drain Strainer**

Broken/missing drain strainer. Furnish and install new drain strainer.

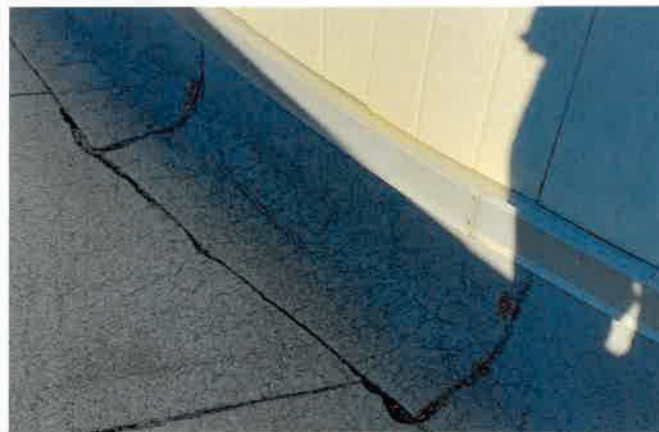
**NW13**

**Non-Warranty - Flashing Lap - Delaminated**

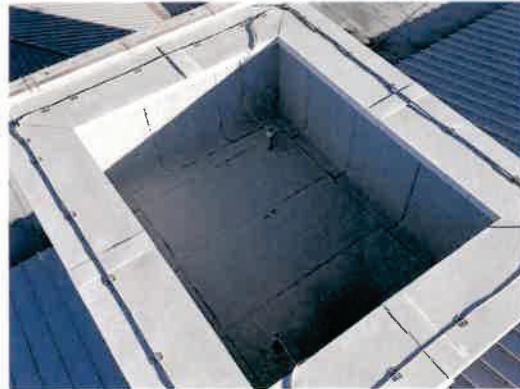
Roof: Roof O

Roof System: Modified  
Install Date: 2006 - Estimated  
Roof Deck: Metal  
Roof SF: 208

Elevation: 0  
Warr. Name & #: Unknown  
Warr. Exp. Date:  
Est. Service Life: 3-5
