WARNING!
01/19/2010

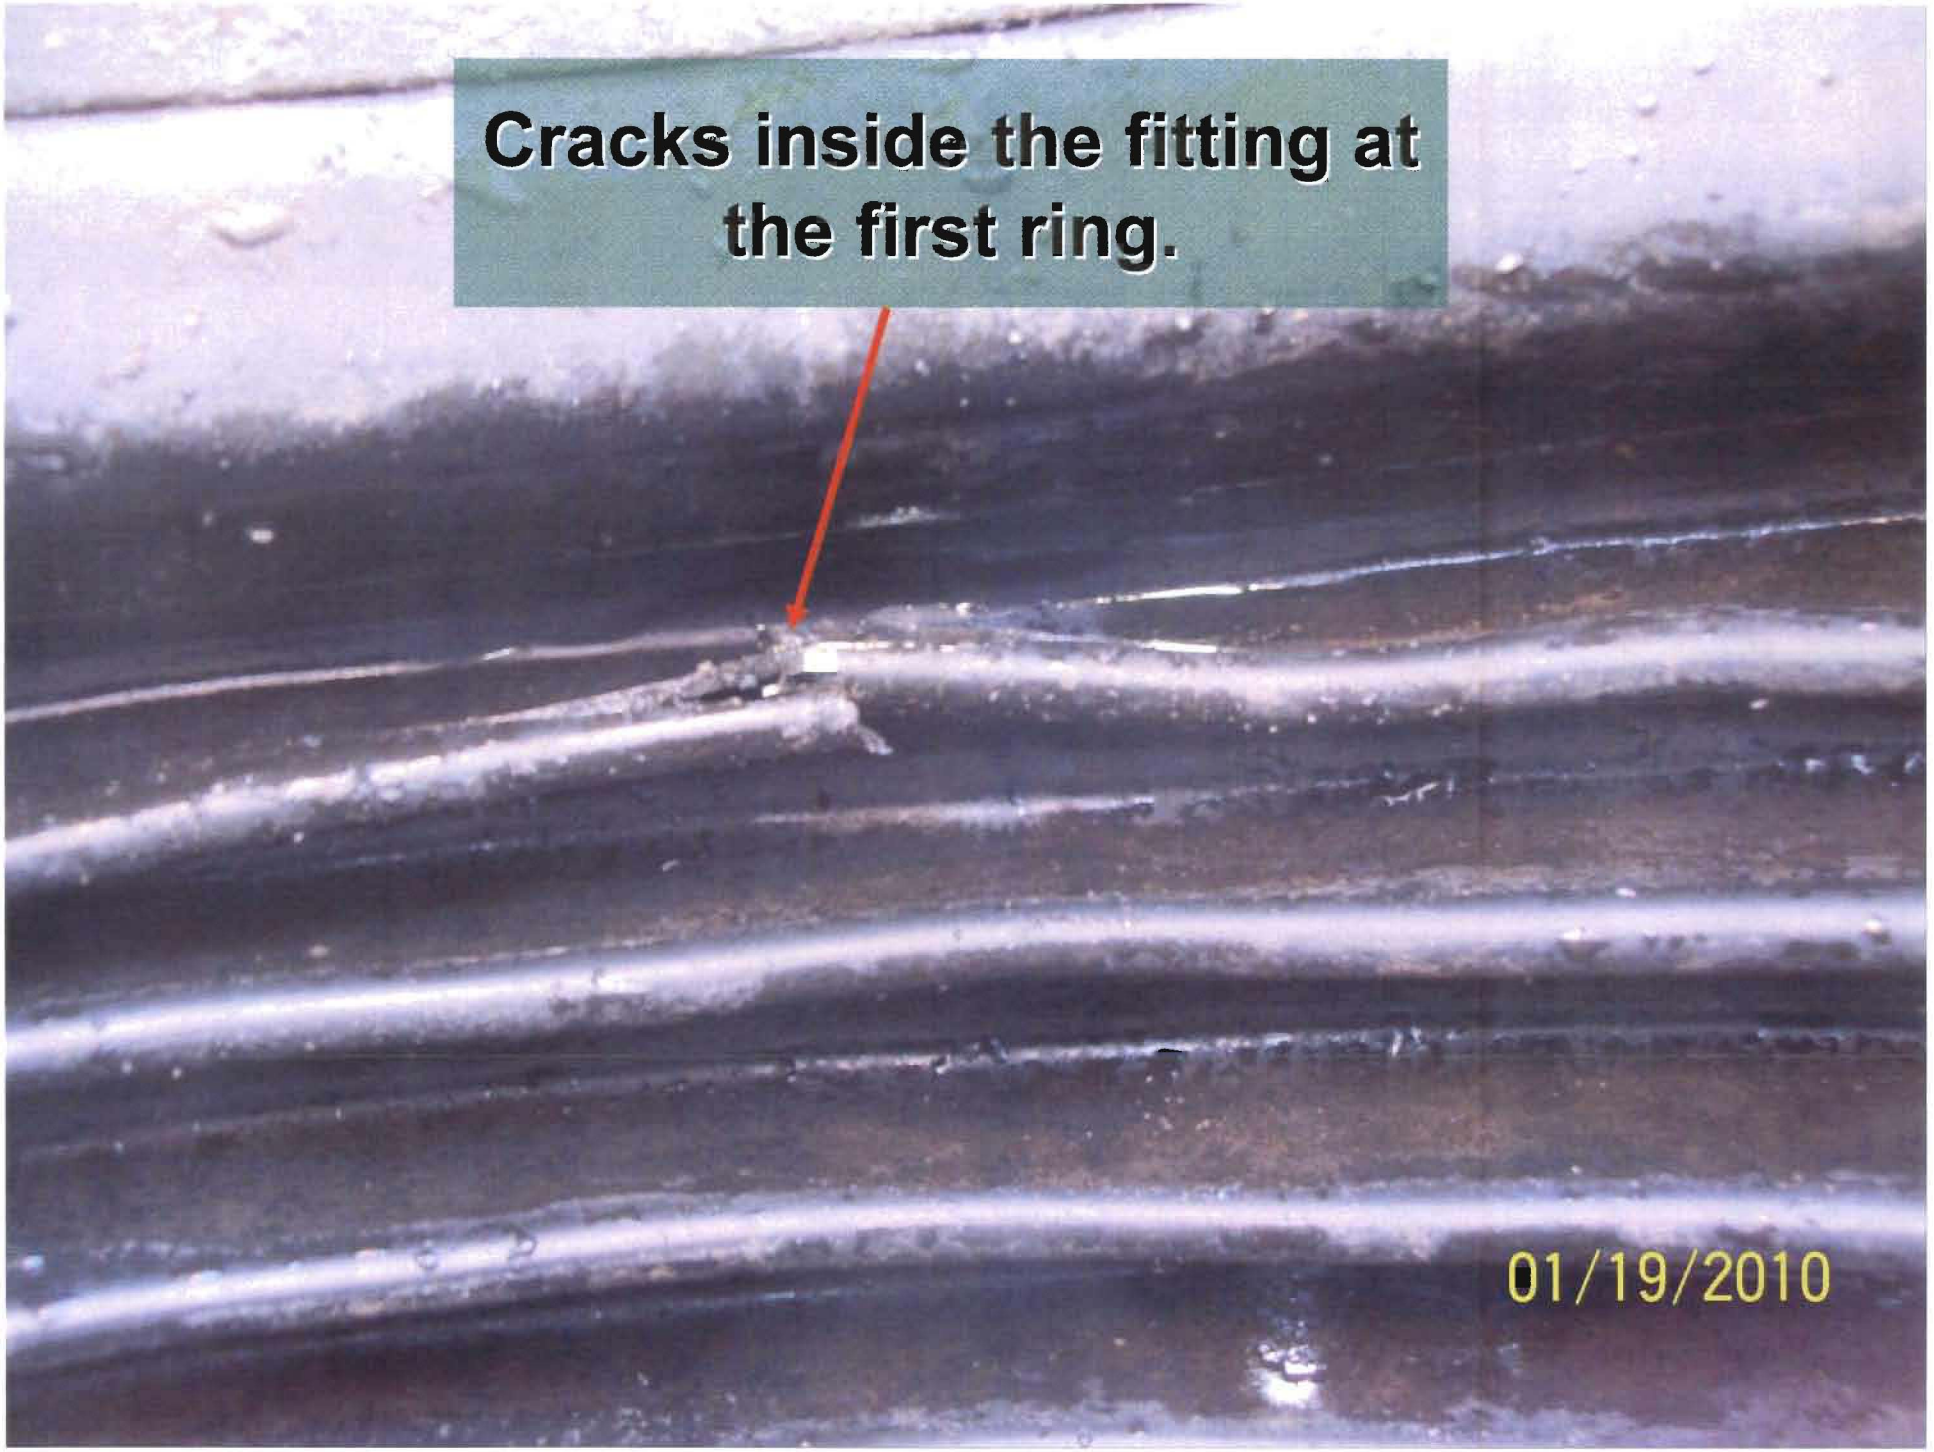
Cracks inside the fitting at the first ring.
01/19/2010

The sheer valve is underground, below
the bottom of the dispenser.

This is the sheer valve nut located approx 12" below the surface.
01/19/2010
